RESCUING THE HIDDEN EUROPEAN WOODEN CHURCHES HERITAGE

*an International Methodology for Implementing a Database
for Restoration Projects*

Gennaro Tampone and Michela Semplici *Scientific Editors*

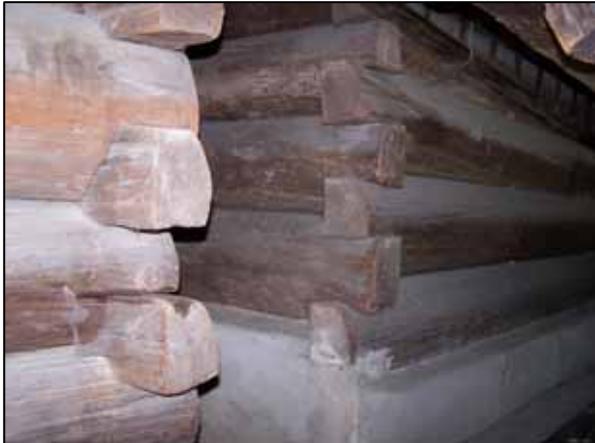
3. Guty, (MO); framed construction of the walls with „remainders” – local builder’s work

4. Framed construction of the walls; 15/16 century;executed by professional carpenters - the joints with „buried tenon” stiffening the joint

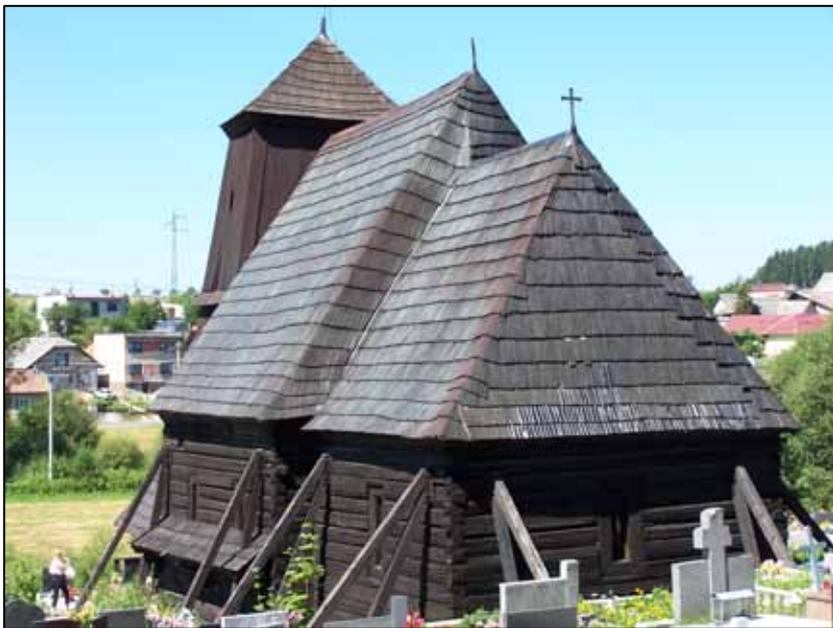
6. Churches with two independent roofs of nave and chancel;

Left: Guty (Mor) and Trnove (Slo)

Pniów (Pol) – built 1506 – longitudinal section

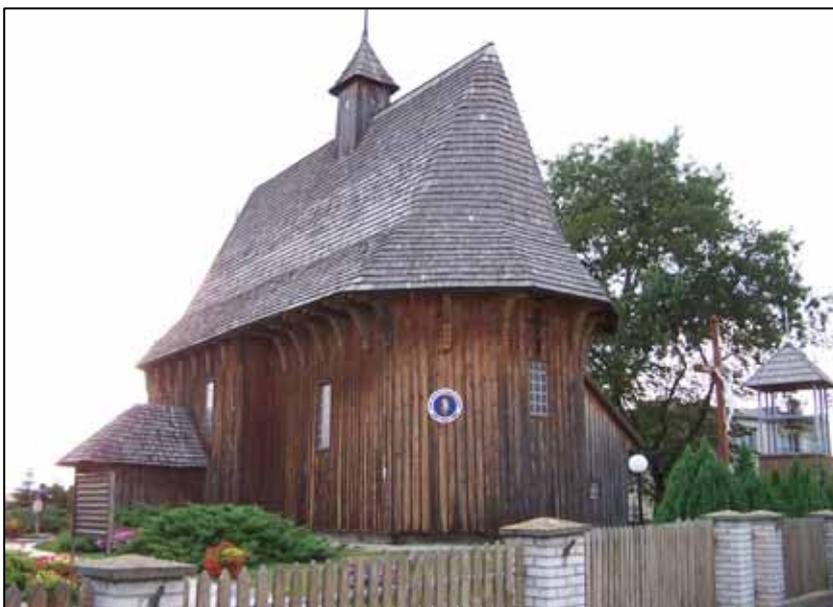
7. Łaszew (PL), church with homogeneous and continuous roof of nave span

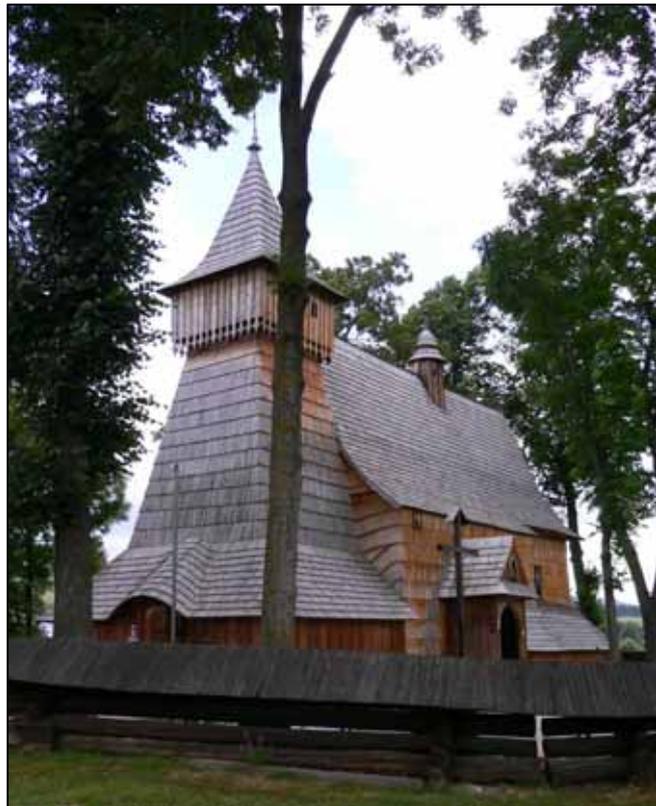
10. Churches with roof resting on „box” over the nave

Debno (PL)

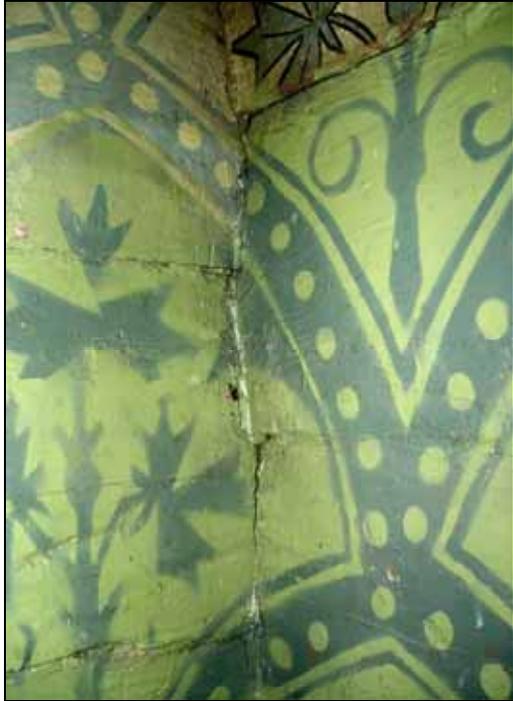
12. Brwilno Górne. Church of St. Andrew the Apostle. Church interior. Southwestern corner in the nave. The method of joining the logs at the corners is visible.

The church is raised on a stone foundation and sill wall of undressed stone built using cement–lime mortar. The walls are of notch larch log construction worked to form squared edges, joined in the corners with dovetail joints, probably with dowels (such information is found in archival materials and can be confirmed by inspection of the southwestern corner) from the nave interior.

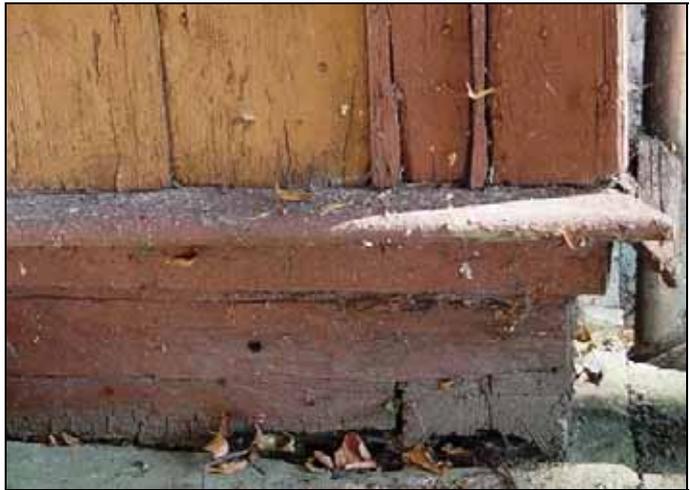
14. Brwilno Górne. Church of St. Andrew the Apostle. Sole plate of the southern wall of the nave. Wooden dowels can be seen.

The sole plate has survived only in fragments. It was partially replaced by concrete inserts in the nineteen–fifties. All facades of the nave are crowned by a cornice of solid logs with a cusp section on a bead.

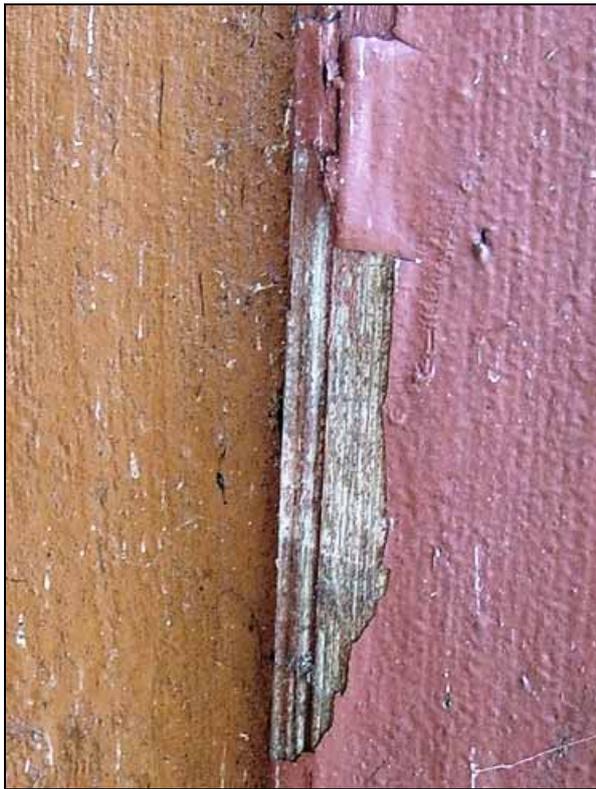
16. Brwilno Górne. Church of St. Andrew the Apostle. Fragment of the cladding of the nave from the north. The uncovered section shows the profiles of the boarding as well as their original color.

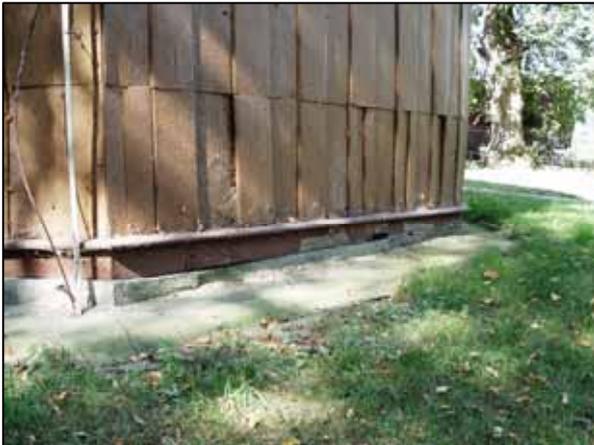
18. Brwilno Górne. Church of St. Andrew the Apostle. Northeastern wall of the chancel. Supplementary cladding dating from the postwar period (1963).

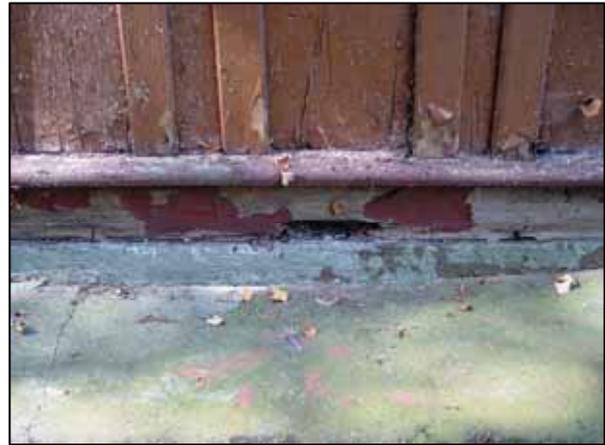
19. Brwilno Górne. Church of St. Andrew the Apostle. View of the northern facade, the lower sections of the cladding, the drip strip, the damaged sole plate, and postwar supplementary work.

The vertical boards of the cladding are chamfered on the bottom so as to overlap a drip strip that protects the boards covering the sole plates and the sole plates themselves against precipitation.

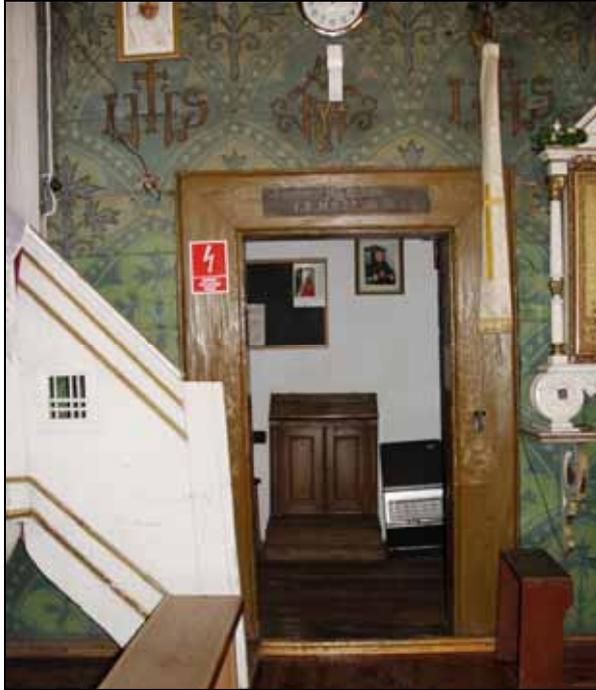
20. Brwilno Górne. Church of St. Andrew the Apostle. Door frame of the entrance from the nave to the sacristy made of logs, as seen from the inside of the church, with molded edges.

Window and door frames are made of logs from the inside of the church, with molded edges, while from the outside, they are covered by molding (made at the same time as the cladding in 1898 and applied on top of the cladding boards).

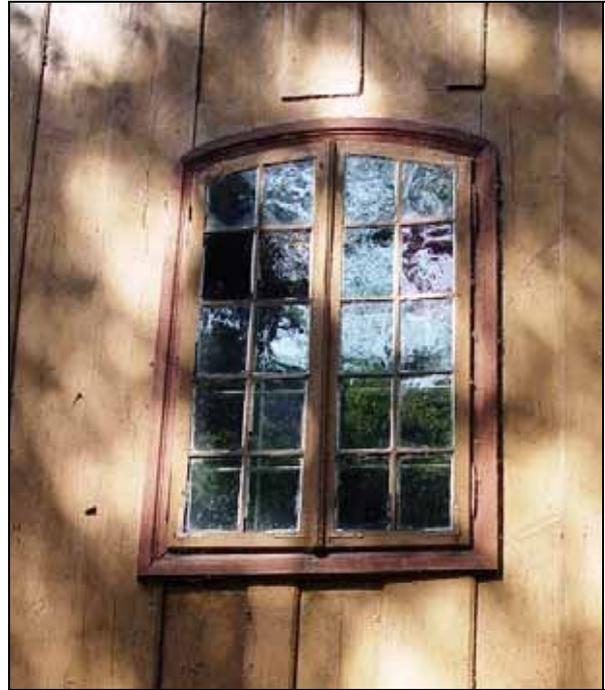
21. Brwilno Górne. Church of St. Andrew the Apostle. Nave windows, southern facade.

Windows in the nave are of the casement type, single, double-sash, with cross muntins attached to the stiles using wooden dowels, with bipartite sashes subdivided into ten sections.

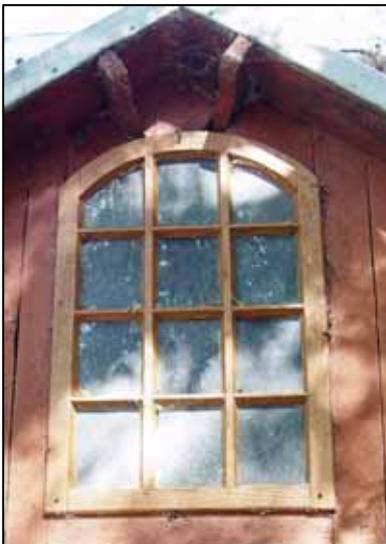
22. Brwilno Górne. Church of St. Andrew the Apostle. Window in the porch with visible wooden dowels joining the frame.

The window in the porch is a single-sash, fixed, window with cross muntins, subdivided into twelve sections, with stiles joined using wooden dowels.

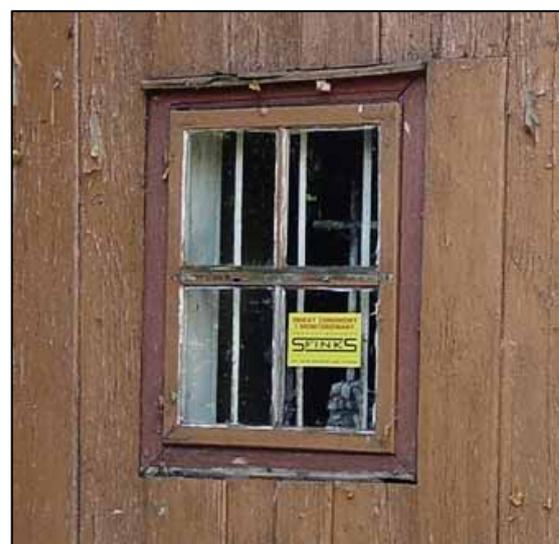
23. Brwilno Górne. Church of St. Andrew the Apostle. Sacristy window.

The window in the sacristy is of the casement type, single-sash, with muntins, a bipartite sash, subdivided into four sections, hung on angle hinges.

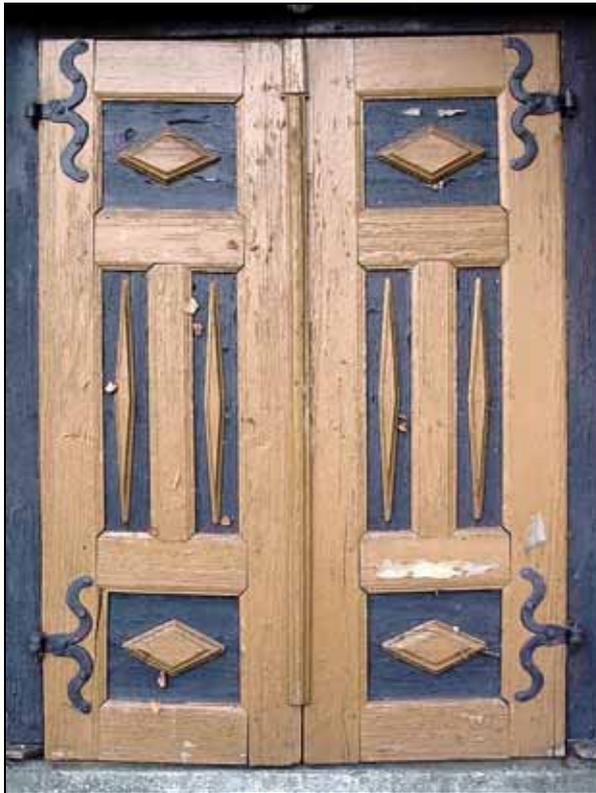
24. Brwilno Górne. Church of St. Andrew the Apostle. Exterior door of the main entrance (probably 1846).

Doors. The exterior door of the main entrance (probably from 1846) is a double door of panel construction, symmetrical, where each half has four panels with molded frame edges, and the panels have cover plates in the form of rhombuses with molded edges; the stile tongue is fluted in the form of a half-column. The door leaves are hung on forged strap hinges in the form of ogees with hobnails.

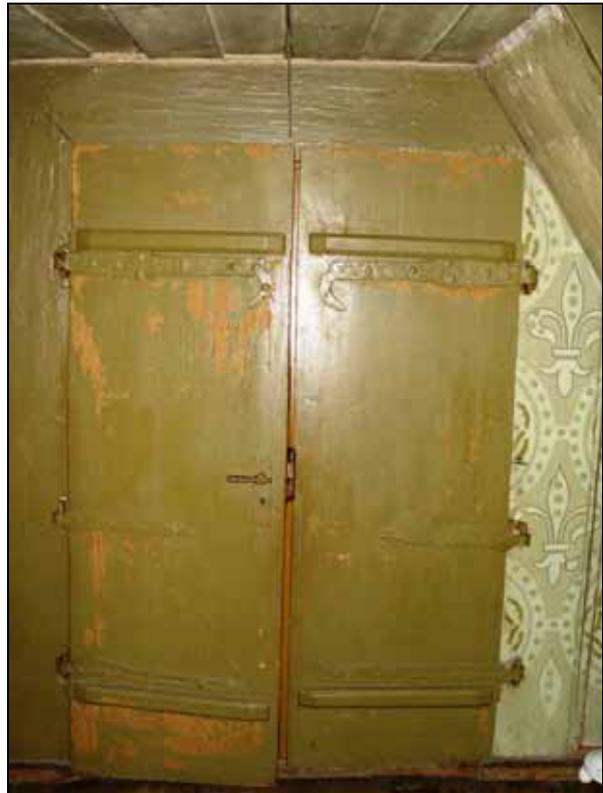
25. Brwilno Górne. Church of St. Andrew the Apostle. The second door in the porch installed in the passage to the nave (probably from the period of the building of the church).

The second door is installed in the porch in the passage to the nave (it probably dates from the period of the building of the church, like the other doors in the nave specified below). It too is a plank and batten double door hung on forged strap hinges.

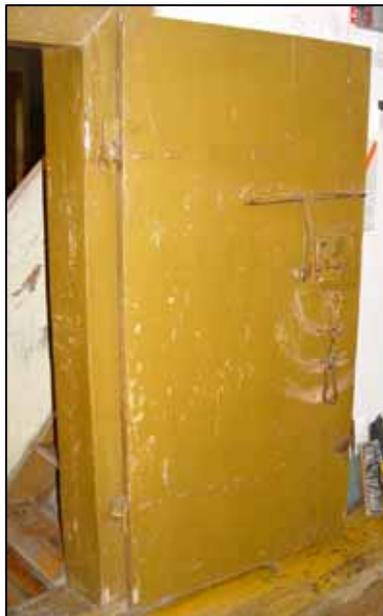
26. Brwilno Górne. Church of St. Andrew the Apostle. Door to the sacristy on forged strap hinges with its original lock, bolt, and chains preserved.

The other doors are single plank and batten doors hung on forged strap hinges with their original locks, bolts, and chains preserved (the door to the sacristy, side porch, and from the main porch to the nave).

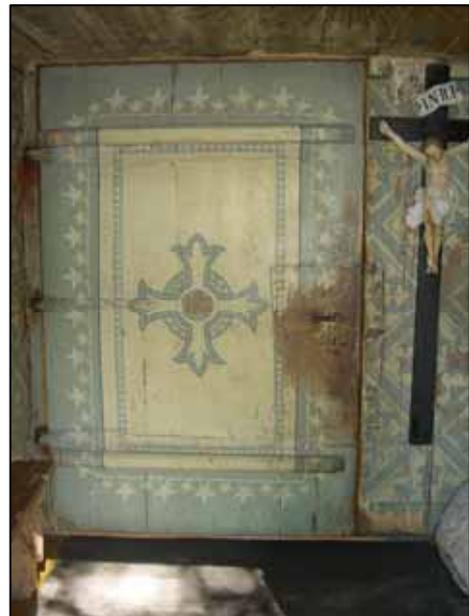
27. Brwilno Górne. Church of St. Andrew the Apostle. Plank and batten door to the side porch hung on forged strap hinges.

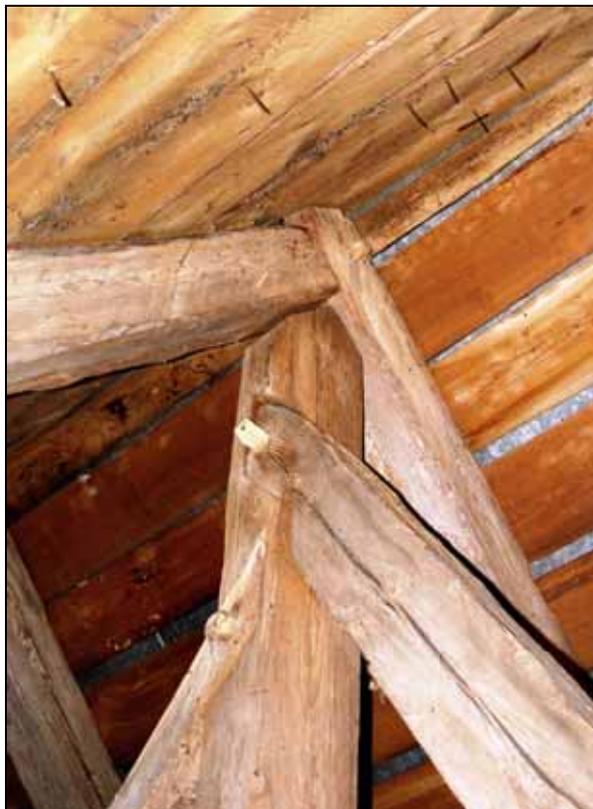
29. Brwilno Górne. Church of St. Andrew the Apostle. Roof structure over the church nave. Connection of the kingposts with the rafters of the ridge. Also visible are the longitudinal brace joints.

The structure includes trench purlins.

The collar beam is joined to the rafters using a dovetail joint.

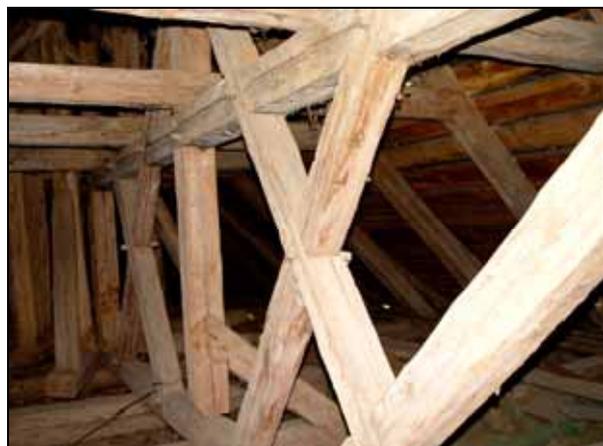
30. Brwilno Górne. Church of St. Andrew the Apostle. Roof structure over the nave. The longitudinal frame.

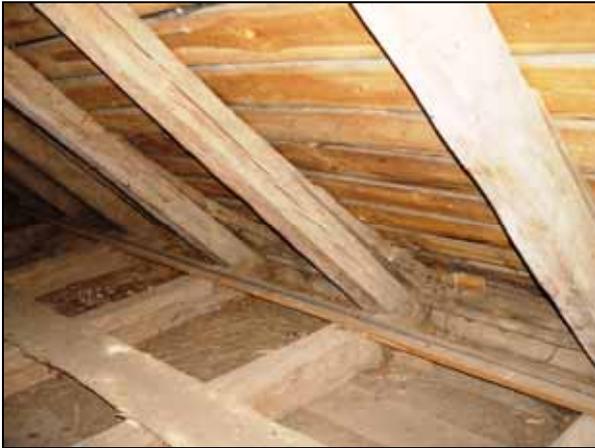
31. Brwilno Górne. Church of St. Andrew the Apostle. Roof structure over the nave. Rafters and trench purlins are visible.

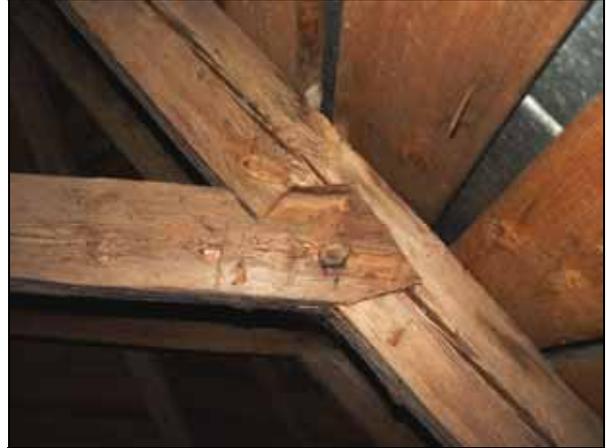
32. Brwilno Górne. Church of St. Andrew the Apostle. Roof structure over the nave. Joints connecting the rafters and collar beams. Carpenter's marks are visible.

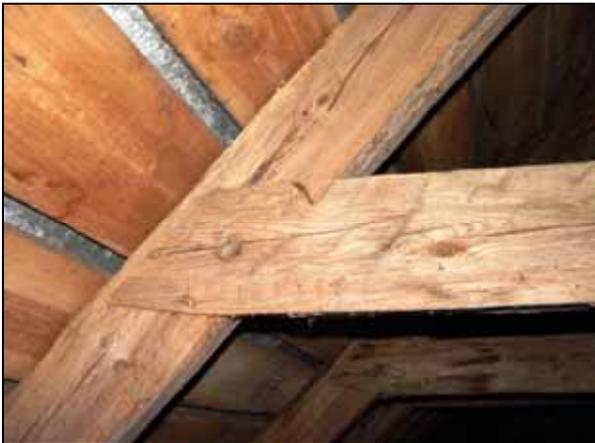
33. Brwilno Górne. Church of St. Andrew the Apostle. Roof structure over the nave. Connection of the rafters and collar beams on the north. Carpenter's marks are visible.

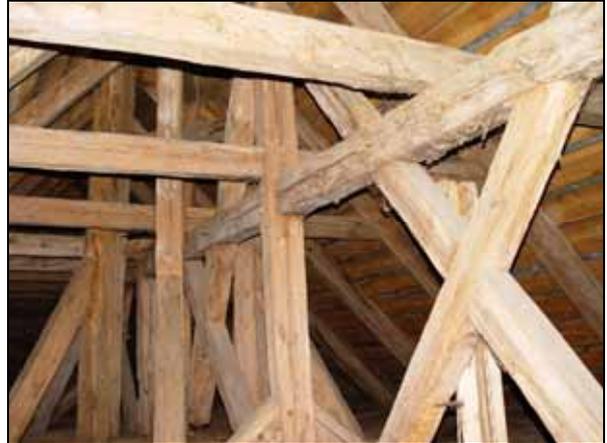
34. Brwilno Górne. Church of St. Andrew the Apostle. Roof structure over the nave. View of the tower and spire structure as well as neighboring roof structure members over the nave.

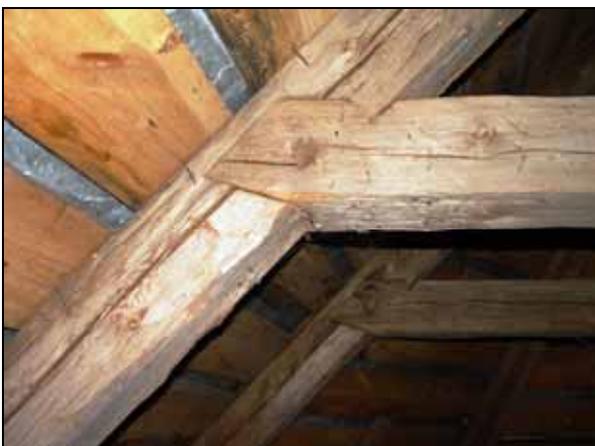
35. Brwilno Górne. Church of St. Andrew the Apostle. Roof structure over the nave. The rafters of the last truss form the west are marked by a carpenter's "x" that signifies its date as being contemporaneous with the oldest members of the roof structure.

The rafters are connected at the ridge using a simple lap joint. There are carpenter's marks visible on the rafters and collar-beams. With the exception of the trusses in the area of the tower and spire, and of course the bell tower, the roof structure of the whole of the nave probably dates from the period of the building of the church.

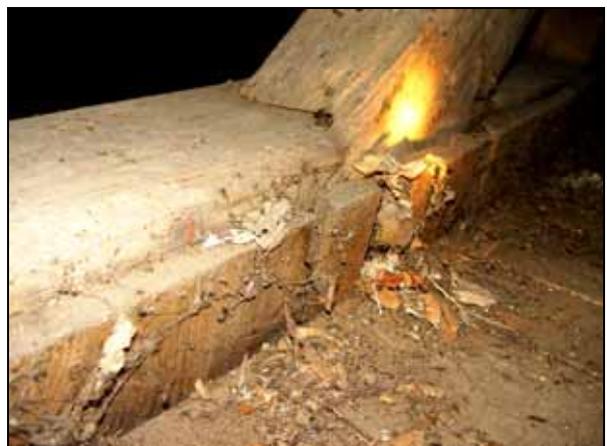
36. Brwilno Górne. Church of St. Andrew the Apostle. Roof structure over the nave. Cladding boards covering the western wall of the nave are nailed to the beam of the last truss.

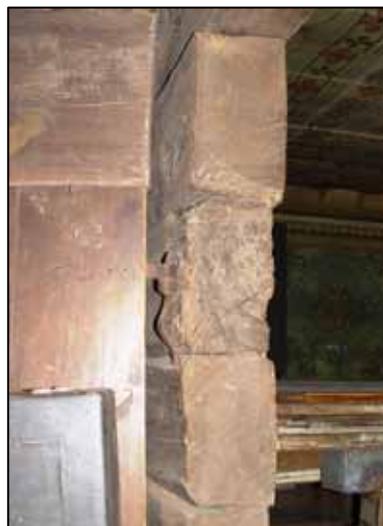
39. Brwilno Górne. Church of St. Andrew the Apostle. Attic of the western porch. A fragment of the door opening made as a secondary cut through the logs of the nave wall (with a single door of boards on strap hinges) can be seen.

These stairs lead to the porch attic and from there to a door opening formed by a secondary cut in the logs of the nave wall (a single door of boards on strap hinges).

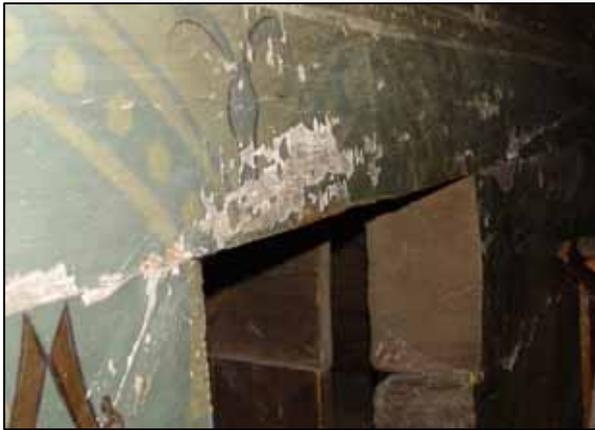
43. Brwilno Górne. Church of St. Andrew the Apostle. Church interior. The western wall of the nave over the choir. The uncovered section shows traces of whitewash—proof of the original finish of the church.

Initially the church was only whitewashed (traces are visible in uncovered sections).

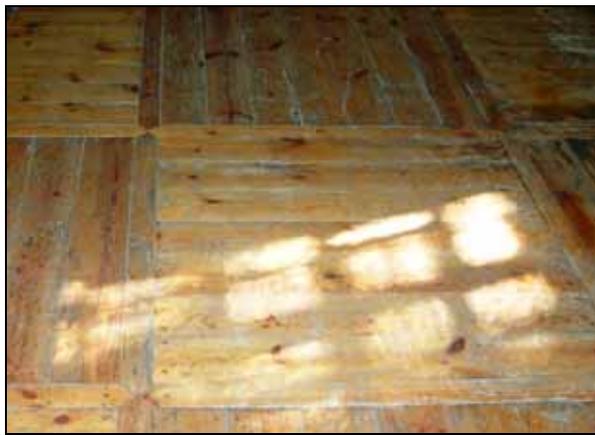
44. Brwilno Górne. Church of St. Andrew the Apostle. Contemporary flooring in the nave made in accordance with that existing earlier.

The flooring is contemporary of boards arranged in square fields along or parallel to the axis of the church in line with earlier models (photograph from 1930). A crypt is located beneath the chancel. It is probably of brick with a vaulted ceiling. The northern wall of the nave contains a passage to the sacristy. The head of the door frame still bears the wording "Fundator Hug Ecclesiae I.R.M.K.P.P. An(n)o D(omi)ni 1740" written in tempera.

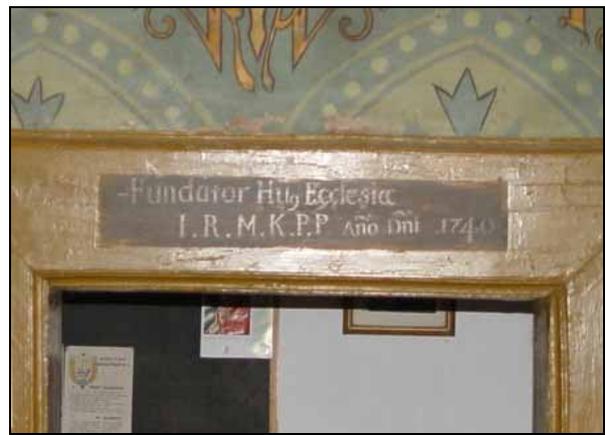
45. Brwilno Górne. Church of St. Andrew the Apostle. The doorframe head of the opening leading to the sacristy in the nave (northern wall) still bears wording in tempera.

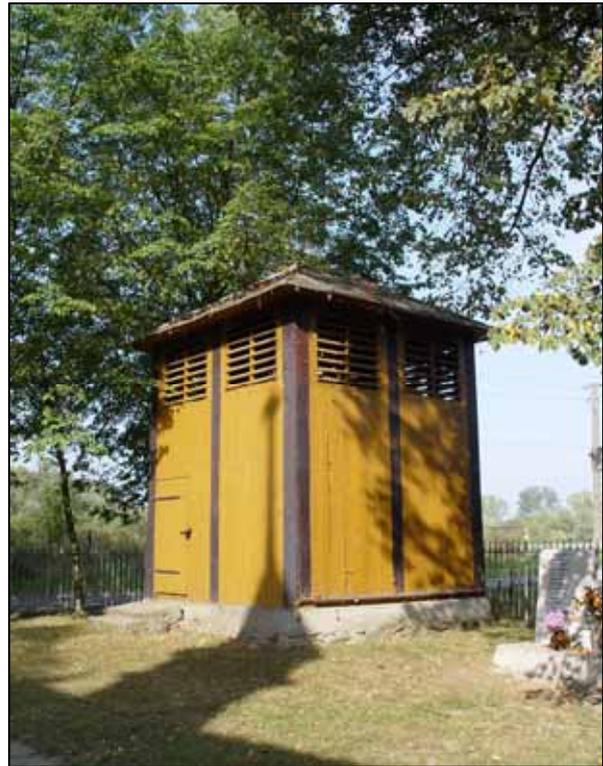
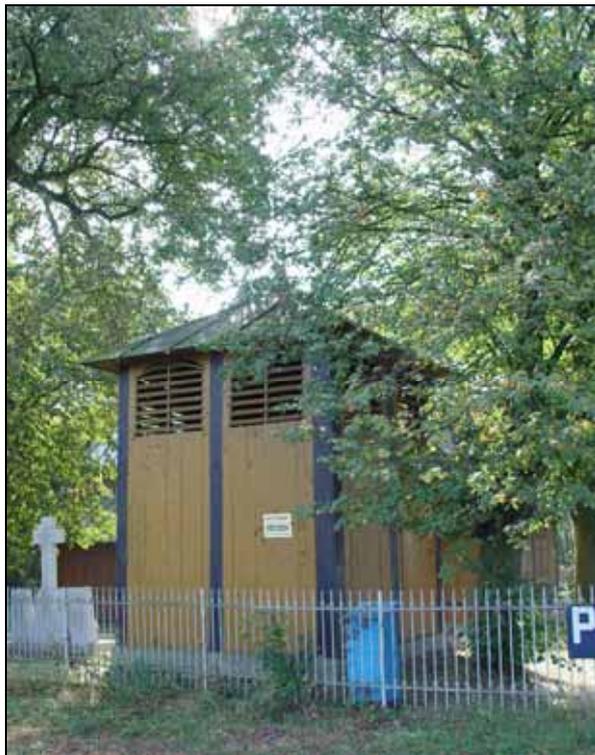
49. Brwilno Górne. The bell tower on the church cemetery grounds. Northern and western facades.

50. Brwilno Górne. The bell tower on the church cemetery grounds. Structure of the bell tower and the bell.

The exterior cladding, in its upper sections, has two symmetrical rectangular window openings cut out from it that close in sections with wooden louvers. The exterior facades are painted, as in the case of the church facades, with oil paint of a yellow–brown color, with dark brown corners. The central post in the interior bears the inscription “1882.” There is no doubt that this is not the year of construction of the bell tower (it may be the date of a renovation of the facility, which was not noted in any sources). The structure shows signs of missing members—struts and spandrels.

The building has no floor. The cladding is from the postwar years. This can be deduced from a 1930 photograph made by Father Turowski. On it the original cladding is clearly different from the present cladding, and the forms

of the windows is different (the windows were narrower and arched, though placed similarly in the facade). Archival sources also confirm this. The new cladding of the bell tower was probably installed in 1947—the year in which the new bell was made and placed in the bell tower. The new cladding most certainly existed prior to 1952—that is the year of information regarding a “new” bell tower “built after the war.”

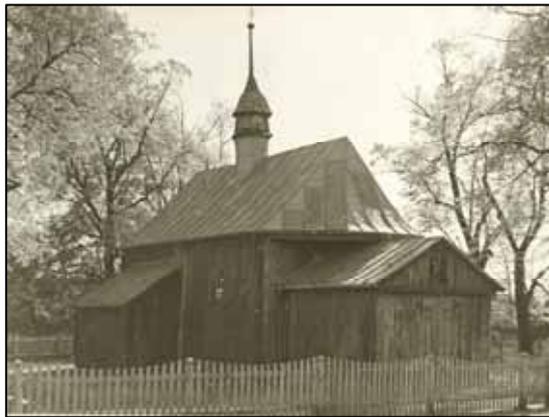
60. The church complex in Brwilno Górne, 1959, Płock Voivodeship Conservator General Archives. A window is visible over the main entrance of the church, which was subsequently converted into a niche for a figure of the Sacred Heart of Jesus.

The church complex fencing was replaced with a new metal fence in 1973 or 1974. At some time between 1959 and 1975, the statue of the Blessed Mother was returned to the main altar, while the figure of the Sacred Heart of Jesus was placed in a niche built in place of a window above the church's main entrance.

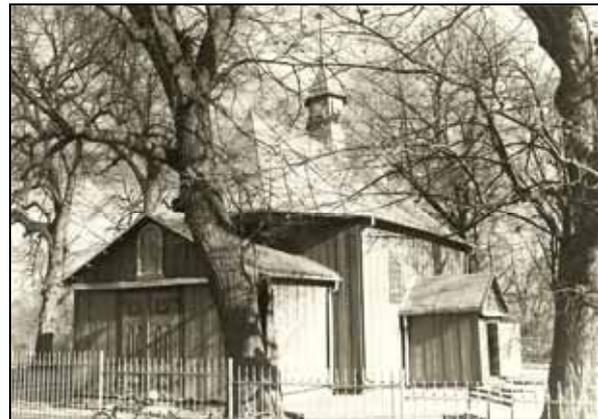
63. The church complex in Brwilno Górne, after 1975, Płock Voivodeship Conservator General Archives. In the foreground is the new metal fencing. A niche for a figure of the Sacred Heart of Jesus was built in the place of a window over the main entrance.

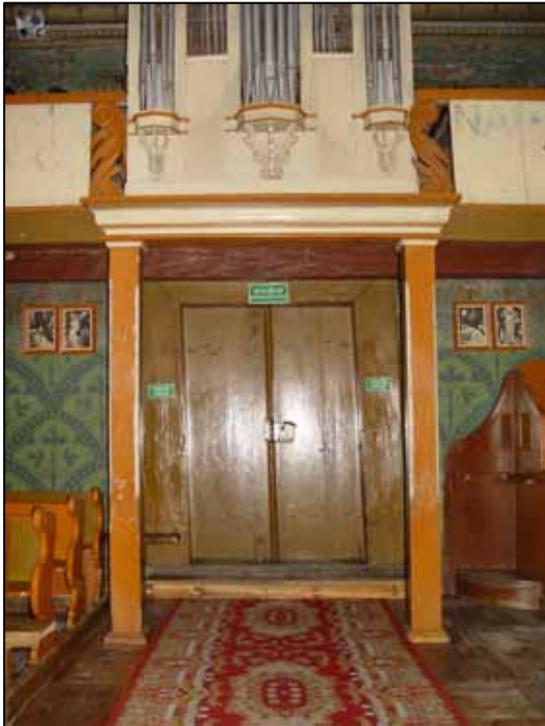
It is only possible to evaluate the surface of the timber logs of the church's load-bearing walls on the interior side because the exterior is hidden due to cladding. The interior surface of the walls does not display any significant damage caused by the development of biological corrosion. However, it may not be ruled out completely. A cause for concern is the numerous cracking of the interior polychrome work at the joints of the wall logs, which may be evidence of the instability and low rigidity of the walls resulting in excessive movement during strong wind loading. However, premature conclusions should not be drawn from the above-described damage as it may have occurred during an earlier period during the elevating of the church walls during the replacement of sole plates in the nineteen-fifties. During examination, excessive settling of the timber wall in the southeastern corner near the chancel was noted, as was the major deformation of the western wall of the church nave. The reason for the settling of the southeastern corner is the biological corrosion of the sole plate in that area. However, it is difficult to unequivocally assess the reasons for the skewing of the western wall of the nave.

One reason may be the leaning of this part of the church in a southern direction as a result of the biological disintegration of the sole plate, signaled in sources dating from 1936. Another reason for the decreasing rigidity of the wall may be the creation of a secondary opening at the level of the choir *empore*. However, in such a case there would be obvious movement of wall logs at the choir level. No such horizontal shifting has been noticed. A third hypothesis for the above-specified damage is the improper execution of the dowels coupling the logs, their excessive clearance, or biological corrosion. The checking of the state of the dowels would necessitate the performance of destructive uncovering over a significant surface, which is not justified. Regardless of the decision taken by the author of the facility renovation design documentation—the aligning of the skewed wall or not—the western wall of the nave requires reinforcement, such as the execution of special cladding on the western side. An exact defining of the technical state of the church walls and the scope of potential reinforcement will not be possible prior to the removal of the exterior cladding. That will also be the moment to take decisions regarding the possible hiding of wall thermal insulation beneath the cladding.

66. Church of St. Andrew the Apostle in Brwilno Górne. Visible skewing of the western wall of the nave.

In summary: The commencement of any work whatsoever in connection with the conservation of the polychrome work inside the church requires the prior replacement of all sole plates after the reinforcement of the walls and the entire structure of the church building. It is necessary to assess the stability of the western nave wall following the removal of the cladding, the dismantling of the spire, the repair of the frame-grid, and its joining with the ceiling beams. After performing the reinforcement and impregnation of the ceiling beams as well as of the roof structure, what is recommended is the execution from the top of a doubling of boarding using 25 mm boards attached by slats to the side edges of the ceiling beams. The existing boarding of the ceiling should be suspended from the above described new boarding layer using special screws. The new floor should receive thermal insulation.

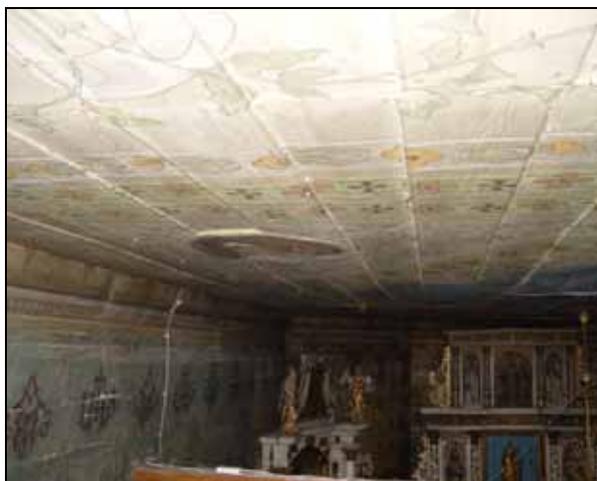
67. Church of St. Andrew the Apostle in Brwilno Górne. Visible sagging of the nave ceiling.

The technical state of the ceiling and its excessive sagging is directly linked with the state of the roof structure. Although true that it was completely built using a collar beam system and therefore is not directly supported by the ceiling beams, due to the timber frame-grid system, its load-bearing is strictly tied with the load-bearing of the beams. As a result of the major span of the ceiling beams, the builder of the facility designed an impressive structural system running along the center of the beams' span, perpendicular to their length.

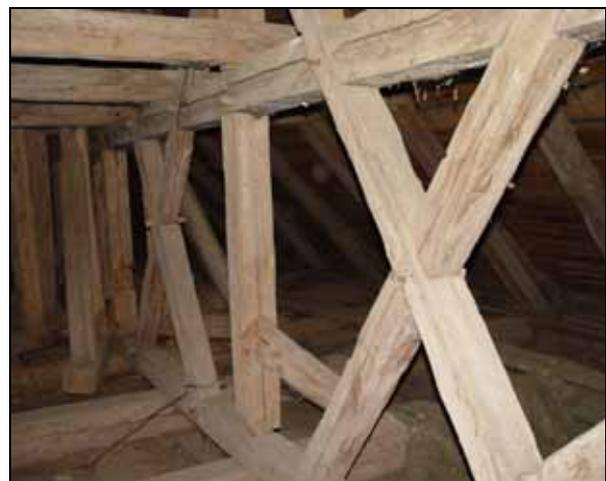
68. Church of St. Andrew the Apostle in Brwilno Górne. The frame-grid of the roof structure.

This structure is supported by the gable walls and not only serves the role of a central truss from which the ceiling beams hang, but also that of a member longitudinally stiffening the roof structure and the facility as a whole. The discussed frame-grid was tied to the beams using timber braces through dovetail joints. During the reconstruction of the spire in 1846, or some subsequent renovation work, the lower chord of the frame-grid was cut without any forethought completely depriving it of rigidity. The result of this was the significant bending of the entire structure in this area. In the eastern section, action was taken to "draw up" the excessively deformed ceiling beams to match the remaining fragment of the frame-grid in the eastern section by connecting them using chains. However, this operation gave opposite effects to those desired.

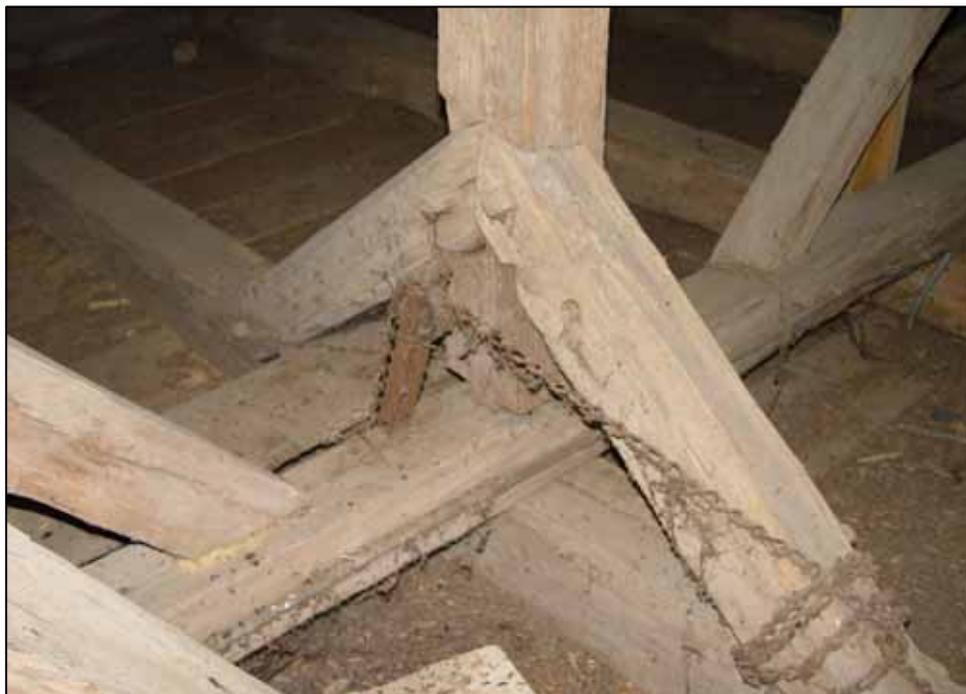
69. Church of St. Andrew the Apostle in Brwilno Górne. Visible "drawing up" of the ceiling beams to the frame-grid using chains.

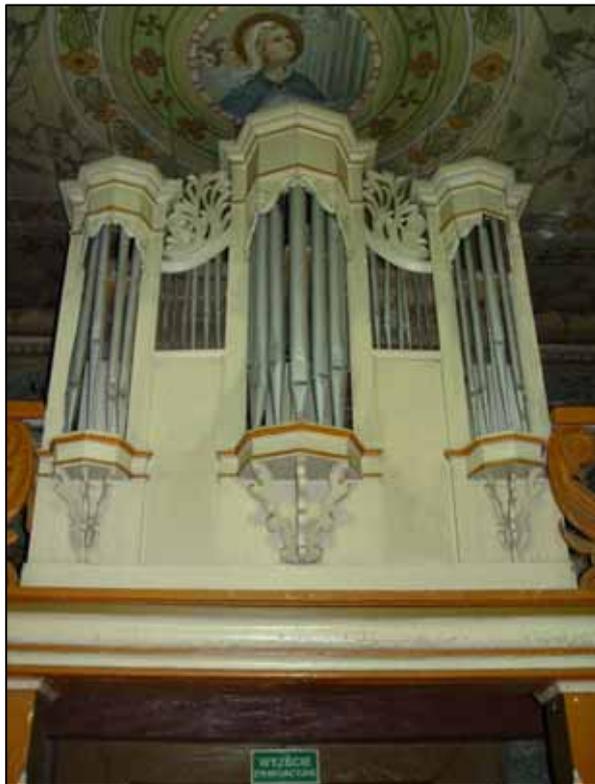
The organ is located in the timber choir supported on two posts. Built as a positive in the choir baluster, it occupies the entire width of the single-nave church. The front of the swell box is based on Baroque models, with three multisided pipe towers (the central one being the larger), separated by intermediate pipe planes. The bases of the three towers are supported by open consoles made of boards with molded edges. The crowns of the towers are richly molded. The upper covers of the pipe shapes in the towers are solid and decorated by stylized bas-relief ornament. The entire enclosure was repainted white using oil paint, while the molding of the towers is ochre. The principal pipes are made of tin. The interior of the box contains the instrument's components. The register manuals are directly connected to the register pistons in the swell box. The pins linking the keys with the abstracts are on a common block and are made of sheet metal. They are inoperative (the interior is destroyed).

96. Church of St. Andrew the Apostle in Brwilno Górne. The organ.

In spite of damage to the organ, the instrument is worthy of the efforts of organmasters-conservators in order to return it to its former technical-musical efficiency. The recommended, necessary work should be commenced with the disassembly of their interior components of the instrument followed by the cleaning of the interior of the organ enclosure and the individual components of the instrument. After analysis of the state of preservation of the pipes, existing damage should be repaired, while missing pipes reconstructed. Missing panels in the organ enclosure should also be replaced. Replacement of the springs in the interior of the swell box is recommended. Perforations present in the existing bellows should be sealed, gluing on an appropriate type of leather. The surfacing of the keys also requires supplementing. The existing stops need regulations. All wooden elements must be impregnated by effective insecticides. Upon the setting up of all component elements of the instrument in their places, the sound ranks should be tuned.

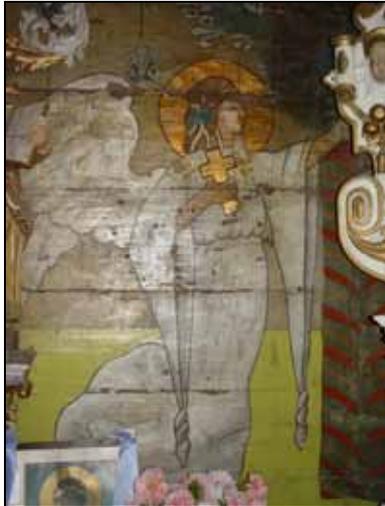
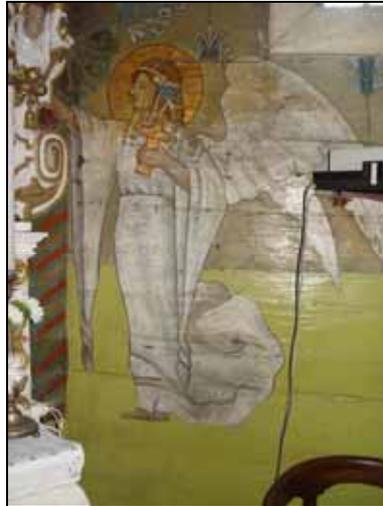
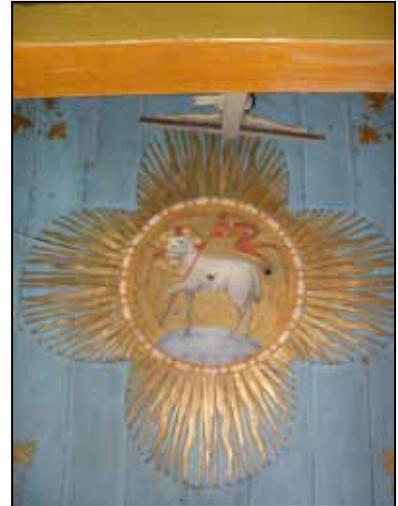
The whole is framed by plant-like ornaments. The space between presented scenes is filled by entwining plants. The polychrome work shows no major losses. There are individual cavities and minor losses along the edges of the boards. What is missing with respect to the original solution is a part of the inscription on both sides of the rood beam and the balusters of the choir.

97. Church of St. Andrew the Apostle in Brwilno Górne. Polychrome work on the walls, the angel on the left side of the main altar.

98. Church of St. Andrew the Apostle in Brwilno Górne. Polychrome work on the walls, the angel on the right side of the main altar.

The polychrome work on the walls and ceiling should be cleaned of dust and dirt, missing wood should be replaced, and losses in the work should be subject to spotting.

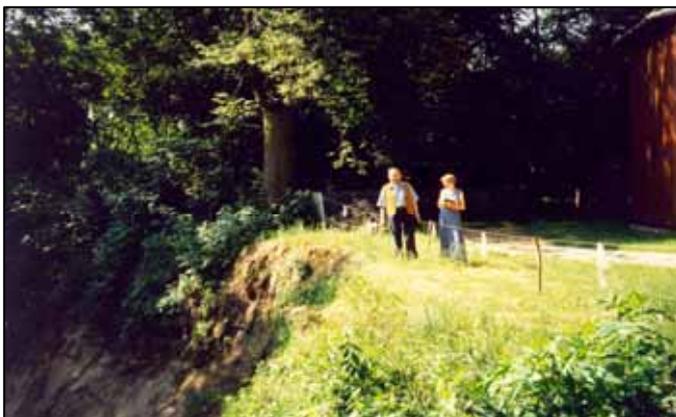
104. Brwilno Górne, church complex, 2002 – the landslide. The wall of the church chancel can be seen to the right. Scan of the landslide.

First and foremost, the trees that fell into the landslide bowl were cut up and removed, as were all other drifts that might accumulate in the stream bed and result in water stagnation. Temporary ditches were dug in order to capture and direct the streamlets of water into the stream. The purpose of these works was to bring about a drying of the coluvium soils and the temporary stabilization of slope failure processes. Operations aimed at a more permanent securing of the landslide were conducted in parallel with the safeguarding work. Prof. Zygmunt Glazer specified several solutions in his report. Their selection is to be based on financing procured for this purpose.

- The direct cause of the landslides occurring on the slope found 7 m away from the church wall, is the zonal influence of water outflow from an approximately 3 m layer of sands found between dumped clay and a layer of varved clay, uncovered at the foot of the landslide slope.

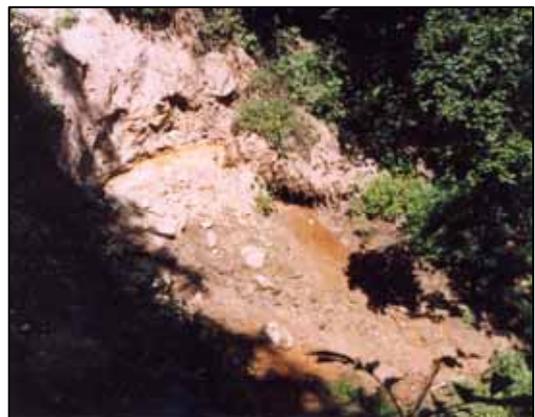
105. Brwilno Górne, church complex, 2002 – the landslide. Scan of the landslide 2.

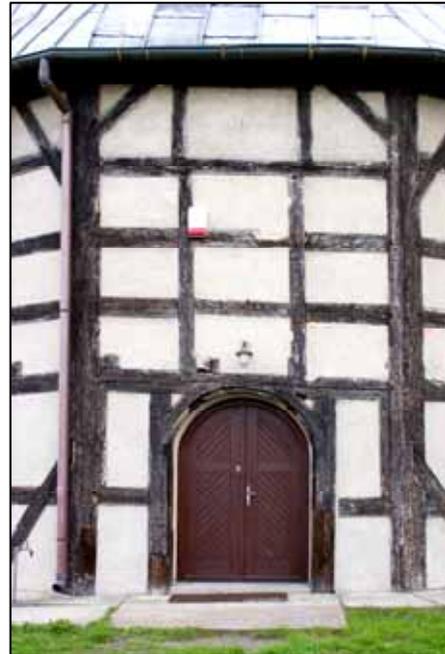
4. Church in Pogorzeliska (Lower Silesian Voivodship) half-timber wall of the presbytery

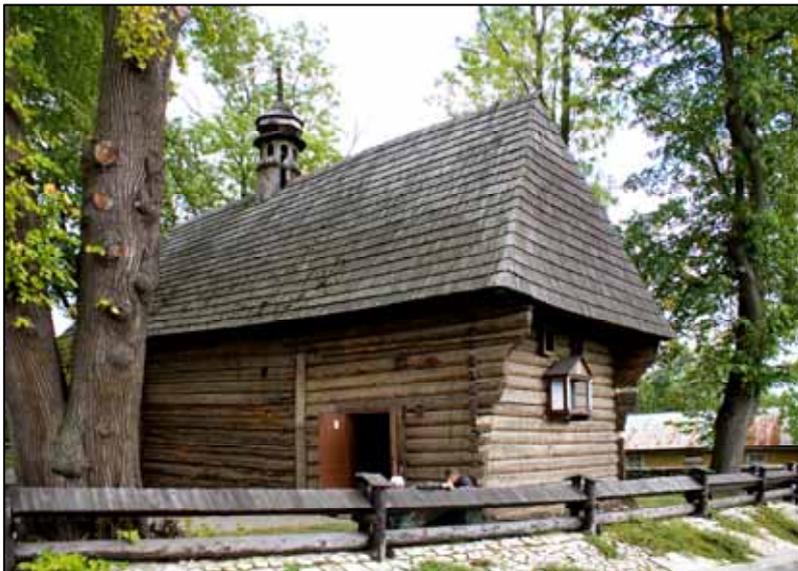
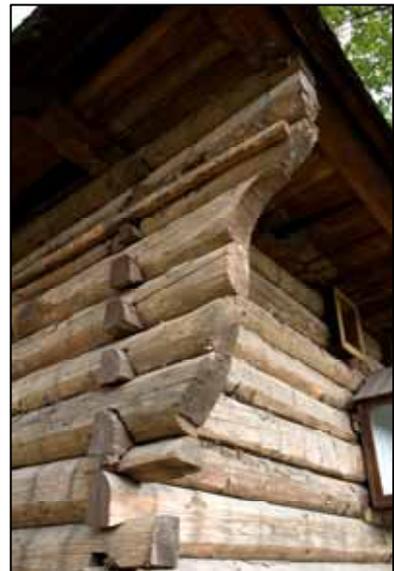
The church has one nave with a sacristy and arcades from the north. Roof is covered with shingle; has a Baroque ridge turret. Inside the old temple there are valuable pieces like: late Baroque main altar with a painting of St. Mark, which was renovated in 2001; early and late Baroque crucifixes, a sculpture of Jesus Christ Resurrected from the 17th century and a painting of Our Lady with the Child. There were also: a sculpture of St. Nicholas and a Baroque epitaph of the Reverend Krzysztof Zawalski, which now can be admired in the new church in Rodaki. The church, like a majority of wooden temples has "soboty" [see translator's note in Ostropa] - arcades supported on pillars, giving a shelter to pilgrims. The church, named the Wooden Pearl of Jura, was put on a list of wooden structures and included into the "Wooden Architecture Route" of Małopolska in 2001. The inhabitants of the village of Rodaki took great care about the church and largely owing to them it survived intact until now. March 1928 is a special date for the church; because of fire, caused by children playing around, all the wooden cottages in the village were burnt, save for the church itself; this was considered a miracle. In 2001, given the 400th anniversary of the church, the local inhabitants volunteered to order the surroundings and in 2003, within a project called "Bell Tower in the Land of White Snow", which was inspired by the Village Council, the bell tower was renovated.

11. Church in Rodaki (Małopolskie Voivodship) view of the presbytery

12. Church in Rodaki (Małopolskie Voivodship) view of the joining of the wall of the presbytery

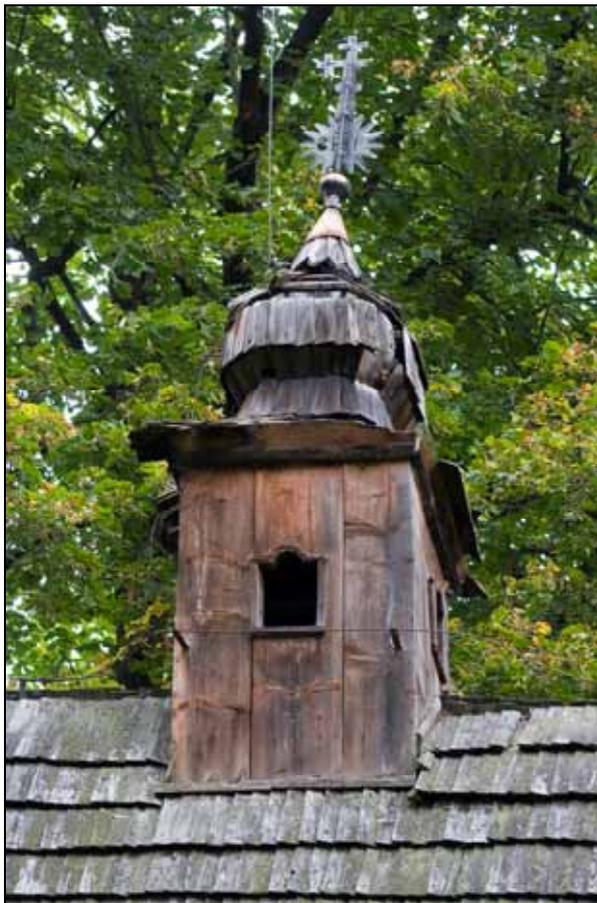
14. Church in Sromowce (Małopolskie Voivodship) view from the west
