RESCUING THE HIDDEN EUROPEAN WOODEN CHURCHES HERITAGE

*an International Methodology for Implementing a Database
for Restoration Projects*

Gennaro Tampone and Michela Semplici *Scientific Editors*

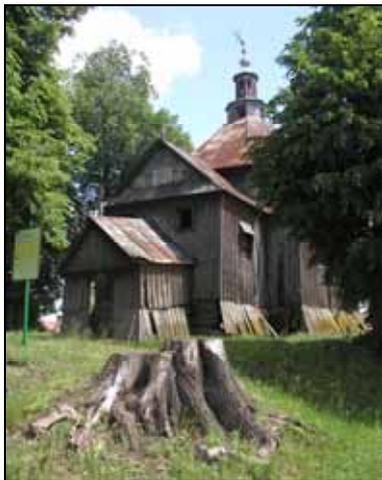
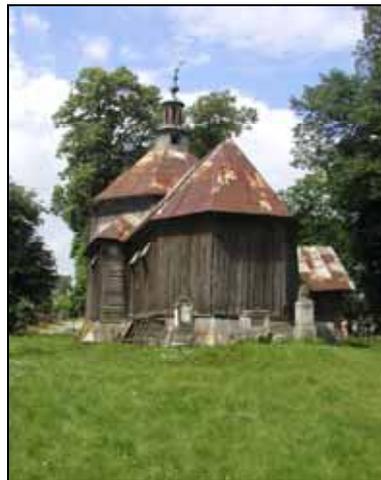
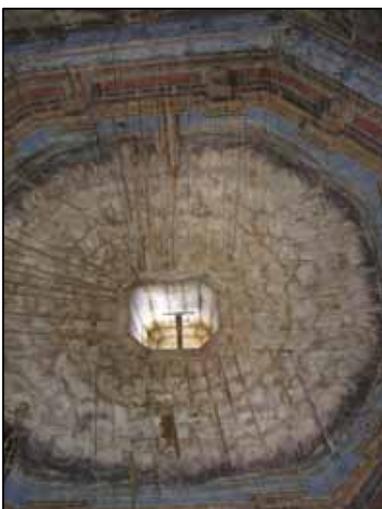
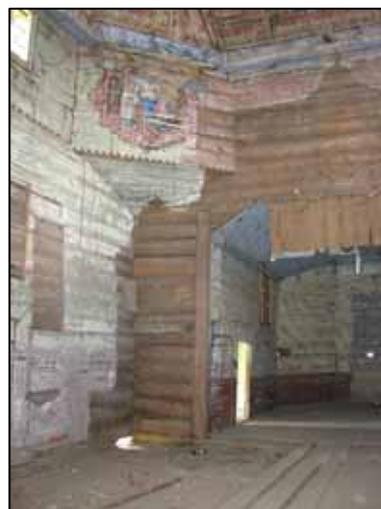
The church itself is wooden, trigeminal, built in a blockwork construction. The structure is not homogenous; the oldest part consists of the walls of the sanctuary in corner-joining construction; in the end of the 18th c. the nave and the women's porch [babiniec] were added (according to T. Spiss, this took place in 1801; other sources, such as *Szematyzmy...* report the year 1811). Most likely in the year 1885 new vaults and roofs were constructed above the sanctuary, nave and women's porch, new sacristy and most likely a proper porch was added, as were wall paintings. It is however not excluded that the present vaults of the sanctuary, nave and women's porch existed since the first enlargement. This seems to be confirmed by the exchange of shingle for a sheet metal roofing in the year 1893 (as the date in the ridge turret has it). In 1916 the church was renovated after damages caused by the war. The choir was enlarged, the roof was renovated and the external planking was exchanged.

19, 20, 21, 22, 23.
Miękiż Stary, state in the year 2006

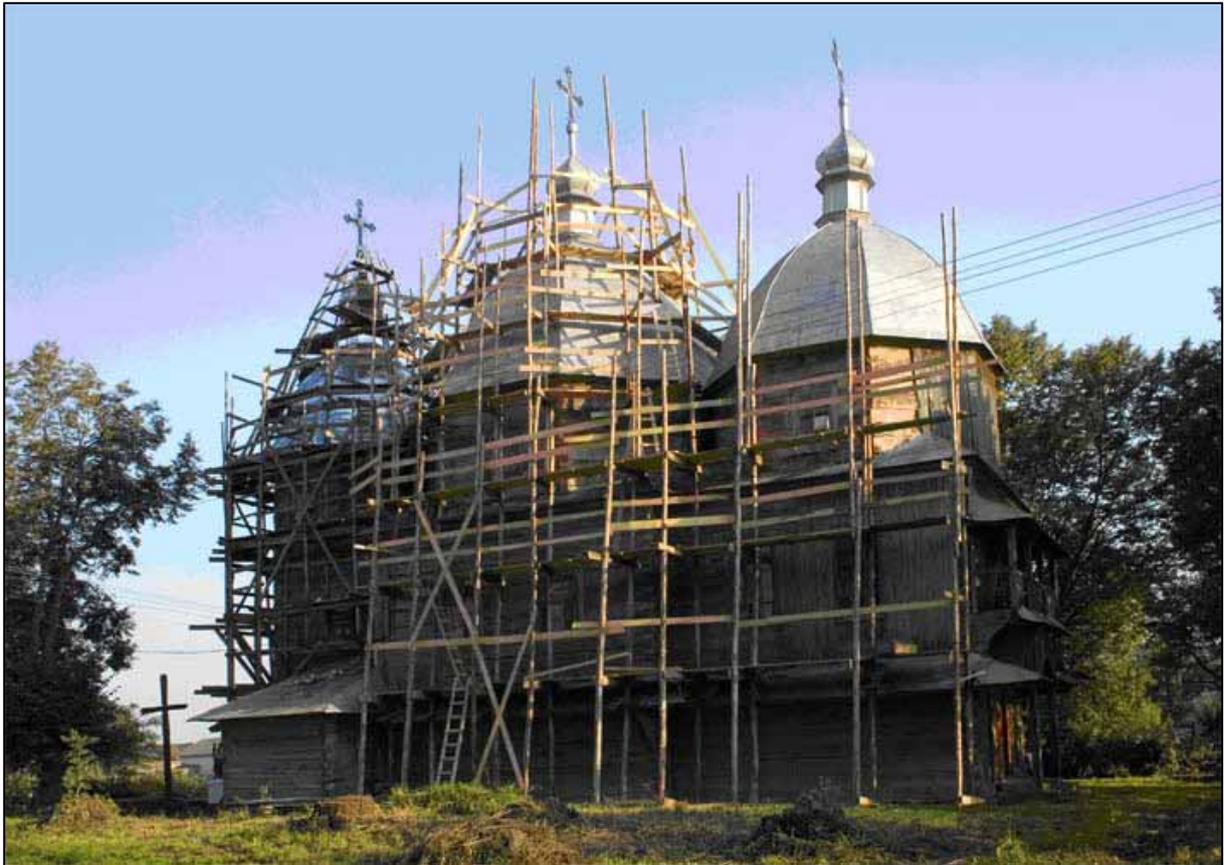
27. Greek-Catholic Church in Budynin (Lubelskie Voivodship) view during the preservation works

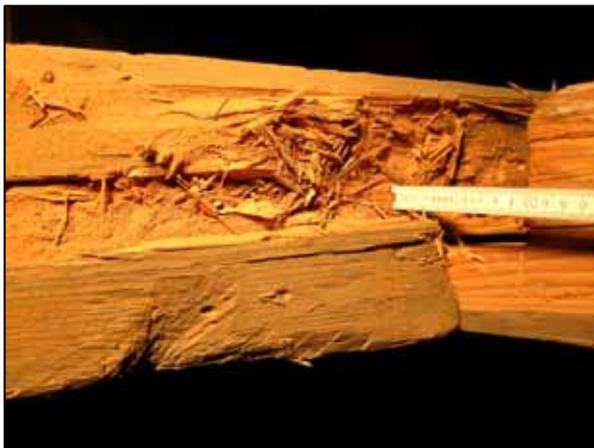
7. Surface damage by wood attack insects, 50 mm depth, Church Prašivá

Mostly these types of degradation effect considerable degradation of wooden elements by larval phase. A number of beetles and weevils preferentially attack rotted wood (see picture below).

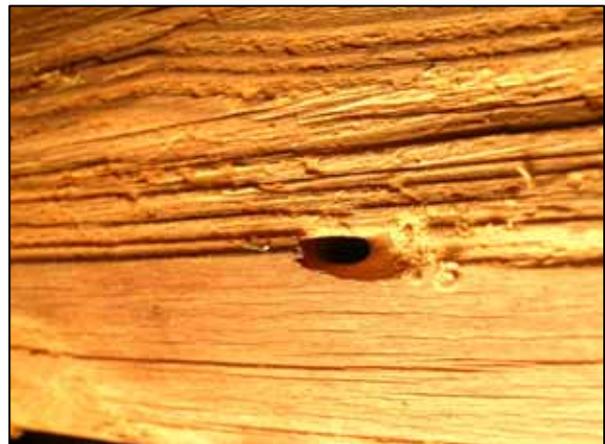
8. Typical oval emergence hole from the longhorn beetle (*Hylotrupes bajulus*), Church Prašivá

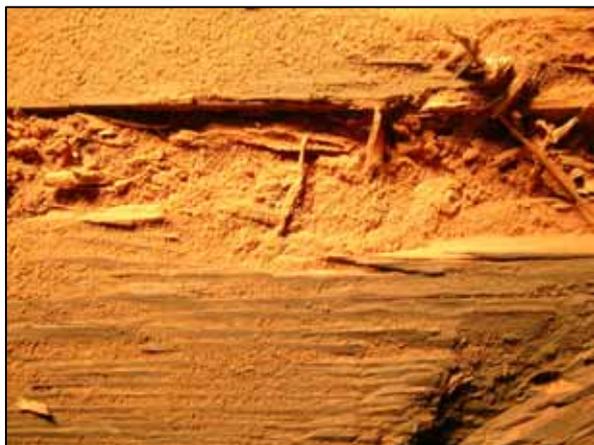
10. Wood damage on surface by insects, existing the bore dust, tunnels, Church Prašivá

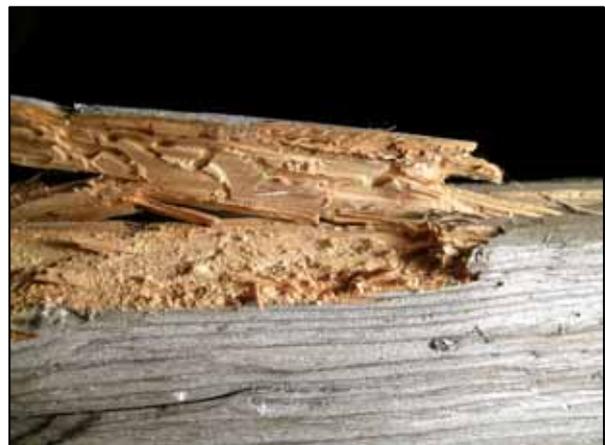
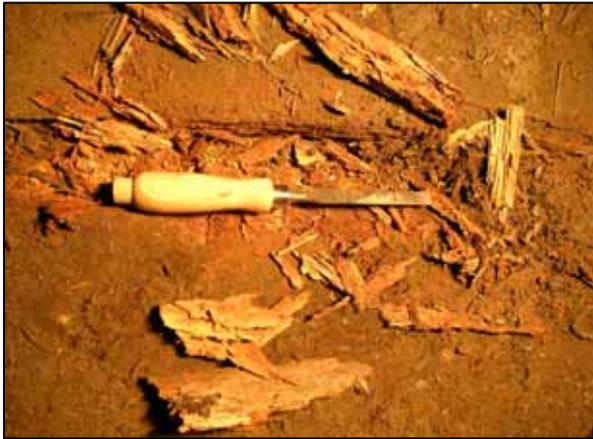
11. Damage of decking of ceiling by insects, Church Prašivá

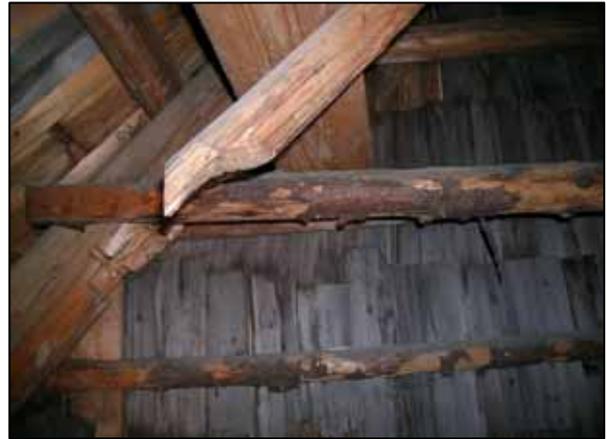
12. Presence of using the un-barked elements in the roof construction, Church Prašivá

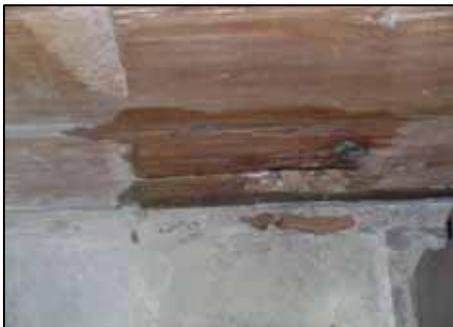
13. Water leaking over the wooden wall frame, Church Albrechtice

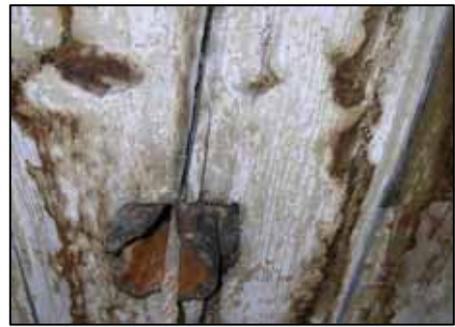
14. Water leaking into the ceiling construction, presence of wood insects' circular emergence holes from *Anobiidae*, Church Sedliště

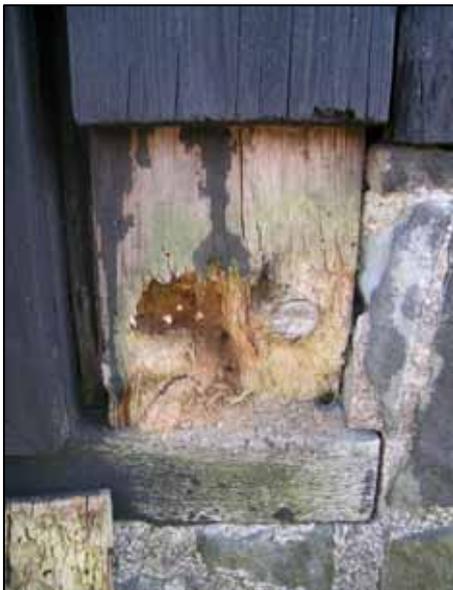
15. Wood degradation by brown rot fungi, Church Albrechtice

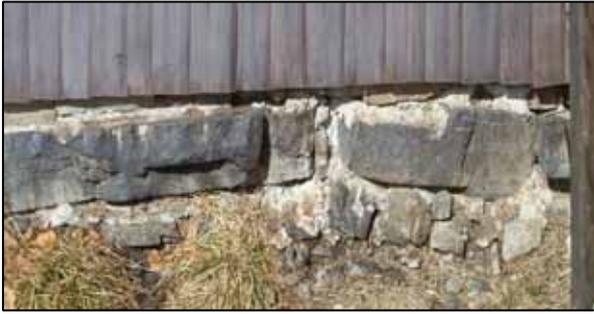
19. Socle of free-laid stones, recently sealed with cement grout.

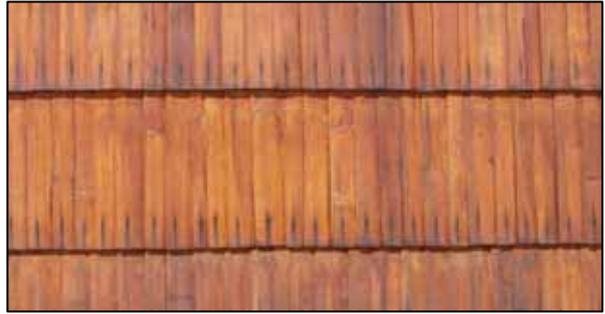
20. Timber walls of hewn timber or round logs covered with shingles.

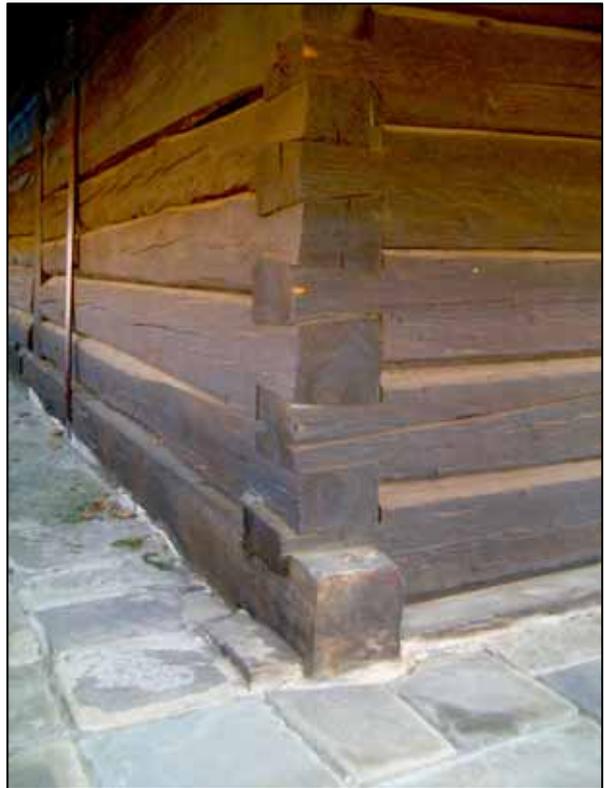
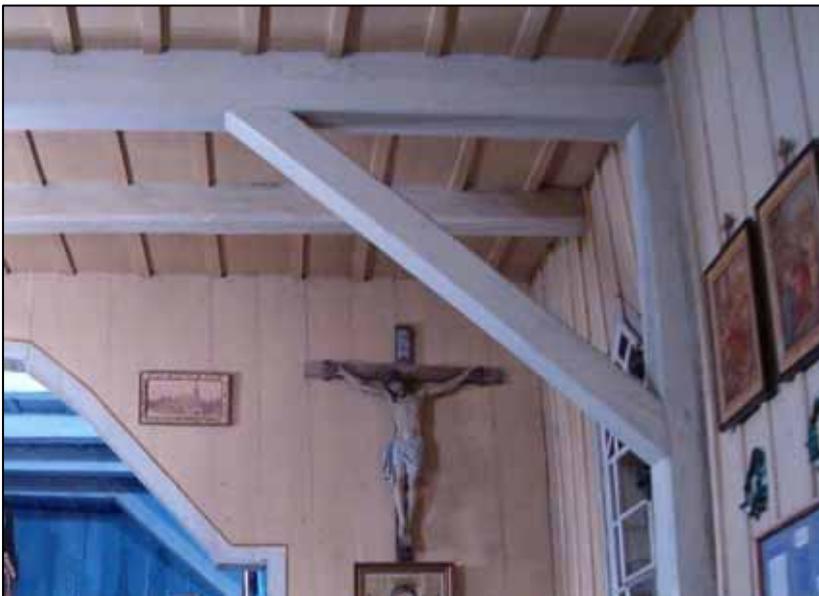
23. Joist ceiling is supported by walls and columns with struts. Beams are also members of roof structure. Several beams are doubled.

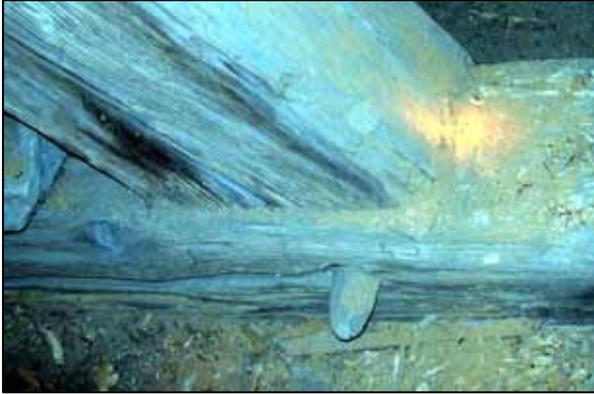
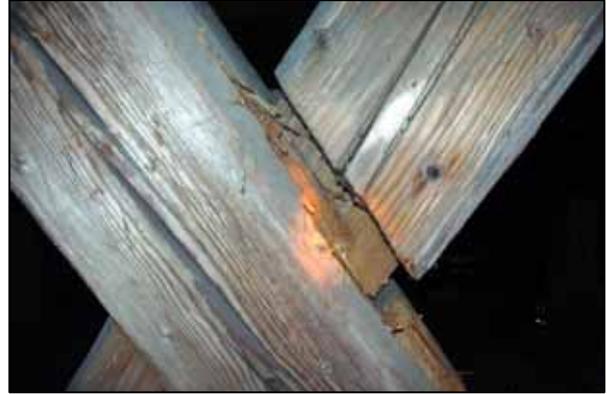
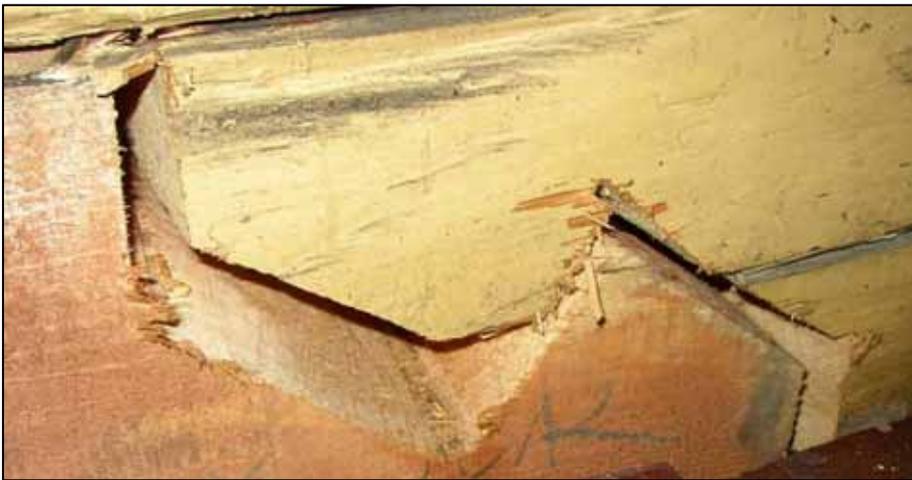
24. Rafters are connected to joist and one or two collar beams. They are supported by columns in principal trusses. Members are overlapped with notched connections with wooden dowels. The detail of mortise and tenon column connection is shown in the figure.

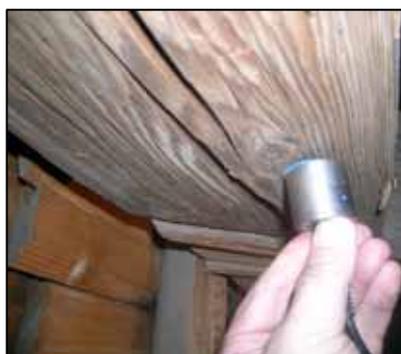
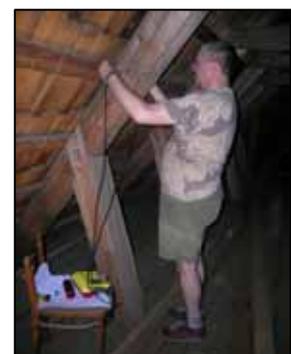
27, 28, 29.

The schema of each measuring is shown in the photographs below. By the comparison of received values of velocity on the each elements should be detected inner damage of wooden materials, certainly measuring should be done and interpreted by qualified person.

The principle of this method is based on the comparison of the ultrasound velocity which is much faster in solid wood than in wood with inner defects. Experiment was measured by the TICO ultrasonic instrument from the Proceq SA Testing Instruments with using the testing probes at frequency 82 kHz.

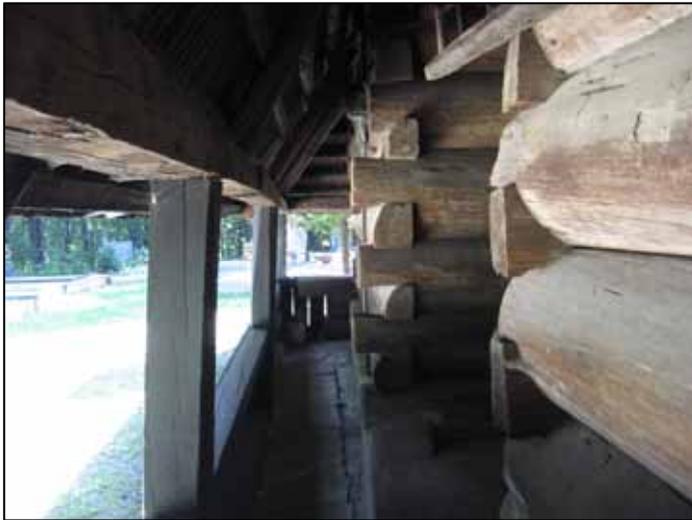
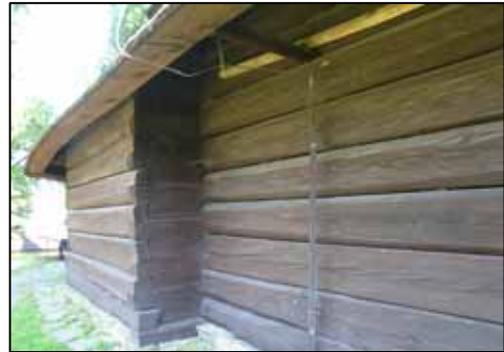
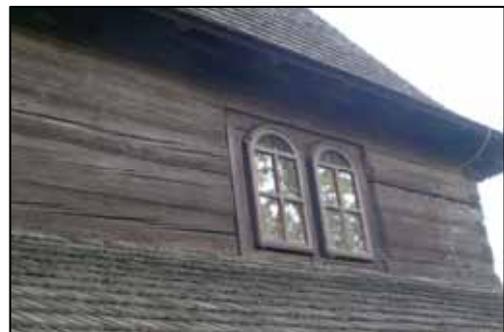
9. a,b,c The modification of the log timber: an undressed circle profile, a) tangentially trimmed profile in two opposite levels, b) a beam with trimmed and rounded edges in four tangential levels.

The log-building beam can have different profiles: either it is left with the circle profile of the original trunk, or it is tangentially trimmed in two opposite levels (Fig. 9a), or it is trimmed in four tangential levels creating a profile of a tetragon (a square, a rectangular, with the cut-down and rounded edges).

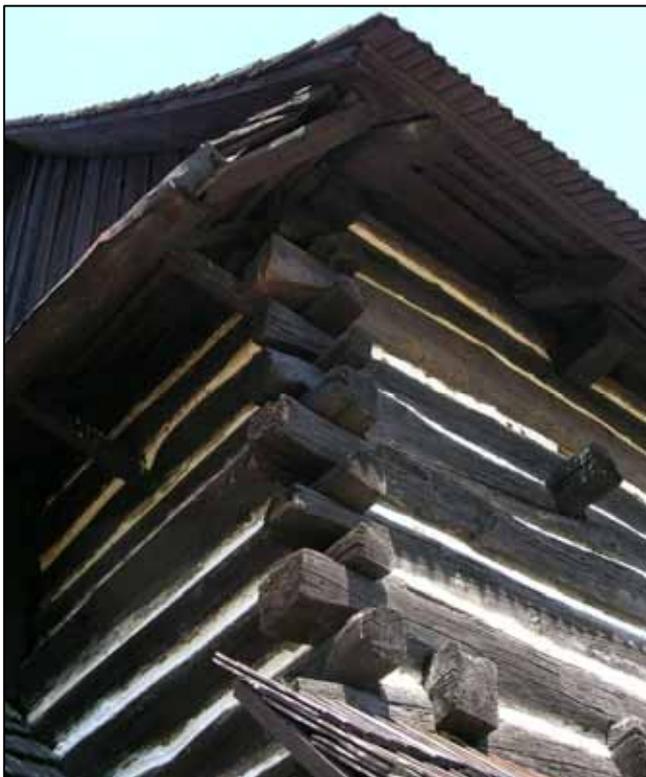
10. Log corner notching.

The wooden churches in Slovakia are all built – apart from the church in Hronsek – by using the log-building technology. All the possible variants of the log modifications - already mentioned above – are present in there. The log corner notching is created from the strong dovetail joint. The corner line has usually got a straight, vertical course. In Brezany, the logs overhang the crossing in the corners creating the characteristic "wings" (Fig.11). The evangelical church in Hronsek has got a post supporting construction with the vertical planking on the peripheral walls (Fig.12). The planking is done from the inner side of the posts, and so the smoothness of the boards are used in the interior. The post supporting construction is clearly perceived from the exterior, which is visually tectonic by diagonally crossed columns and by horizontal wooden bands. It is believed that this construction is of the Scandinavian origin, but the objective historical documents are missing. This construction is uncommon and unique not only in Slovakia, but also in the Carpathian region.

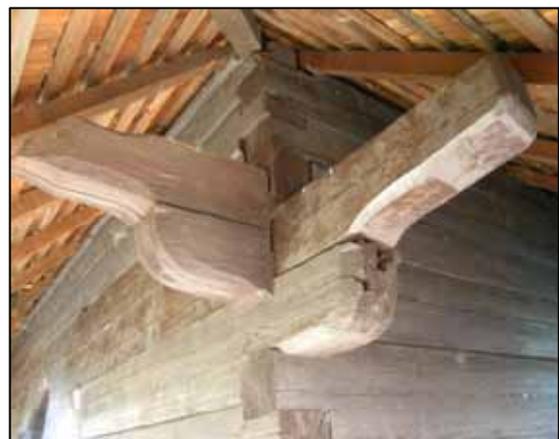
(a) Brezany, (b) Tvrdosin

11. The "wings" of the protruding logs in the corners are unusual for the sacral buildings (a). They are occasionally present in the churches, which have covered footpath running around them in their ground area (b).

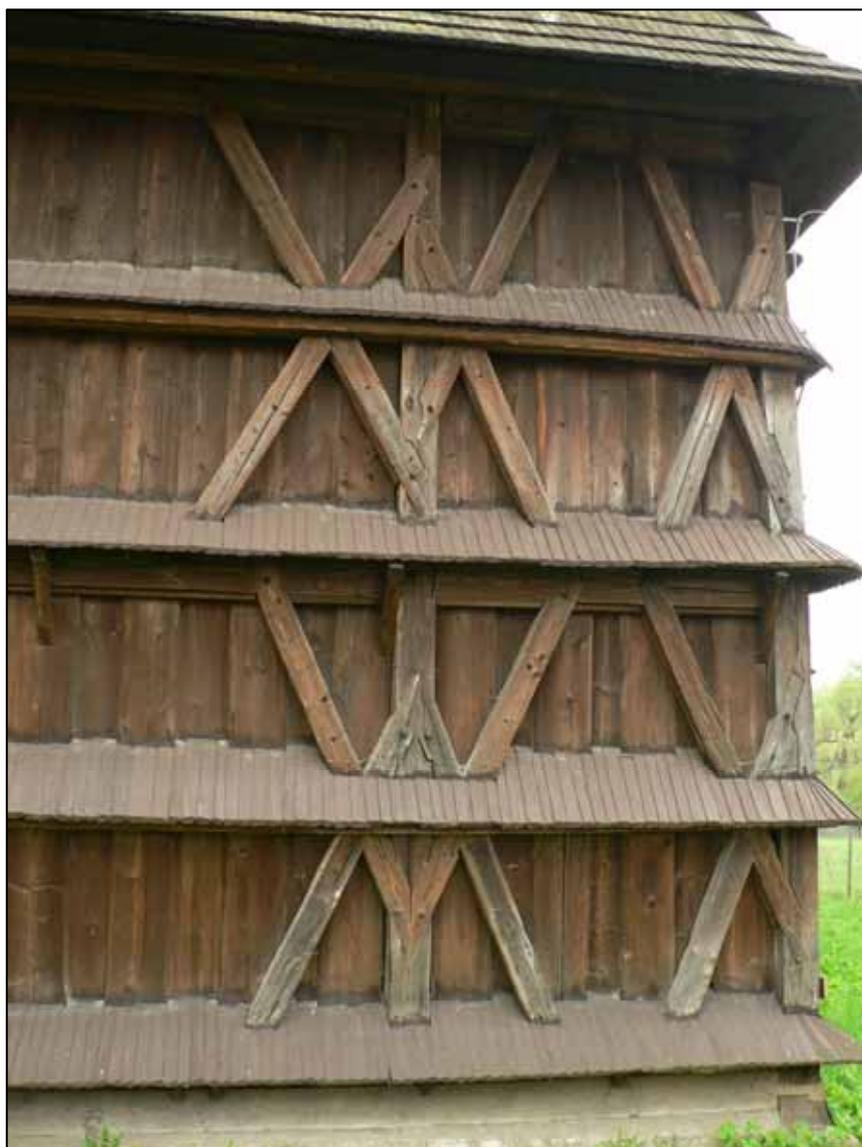
12. The post construction of the church in Hronsek is unique in the observed Carpathian region.

The post construction was used for the constructions of bell towers, built either near churches or farther away. From the constructing point of view, the towers have always been independent from the supporting constructions of the temples. In some cases, they are optically connected with the body of the temples, which is caused by the functional covering of the church roof and the body of the bell tower.

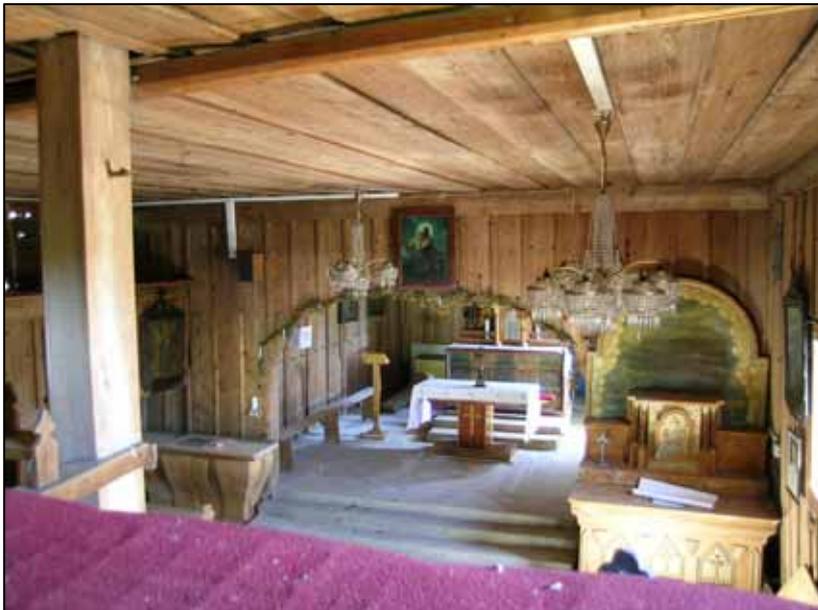
13. The interior ceiling construction in Jedlinka. (a) section, (b) interior

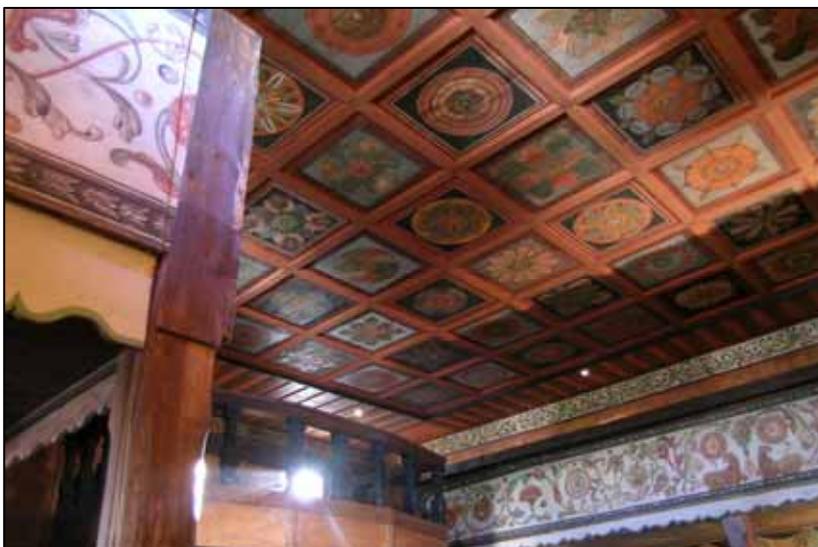
14. The flat ceiling boarding in:
a) the Roman Catholic church of St. George in Trnove near Zilina,
b) church in Hervartov.

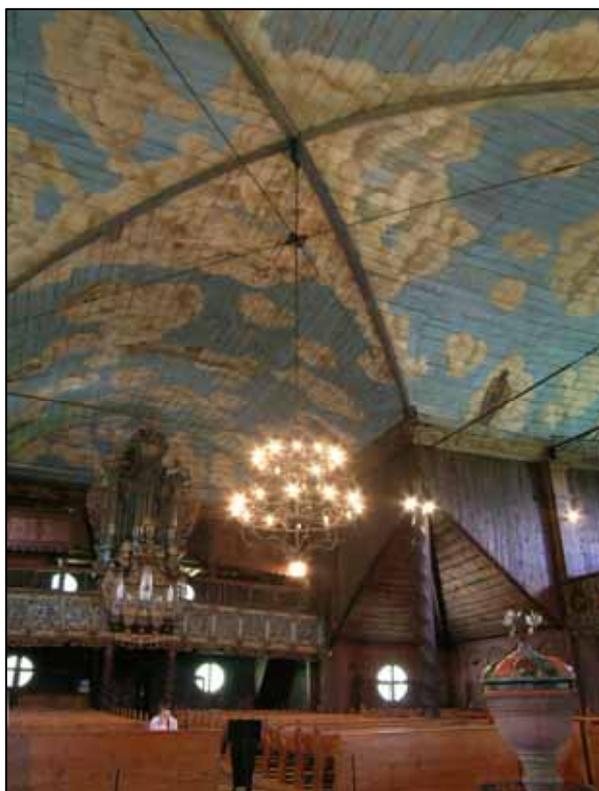
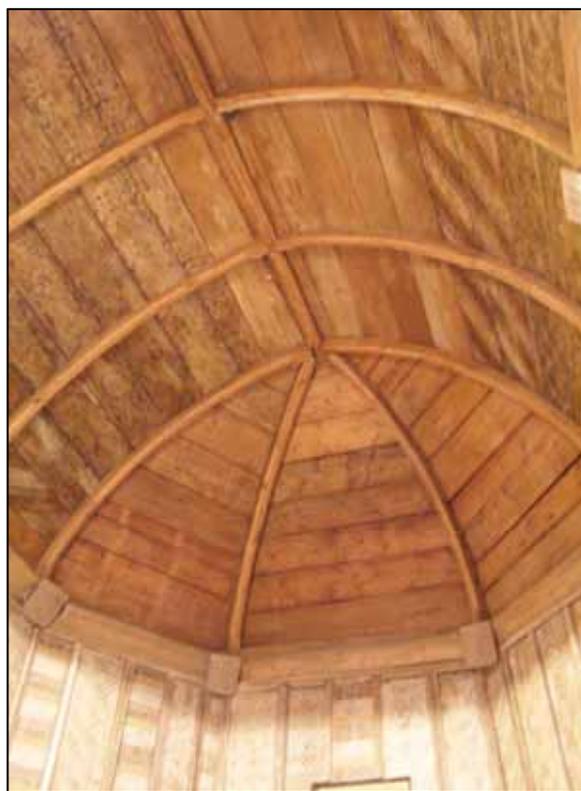
15. The casket ceiling with painted boarding in the church of All Saints in Tvrdosin.

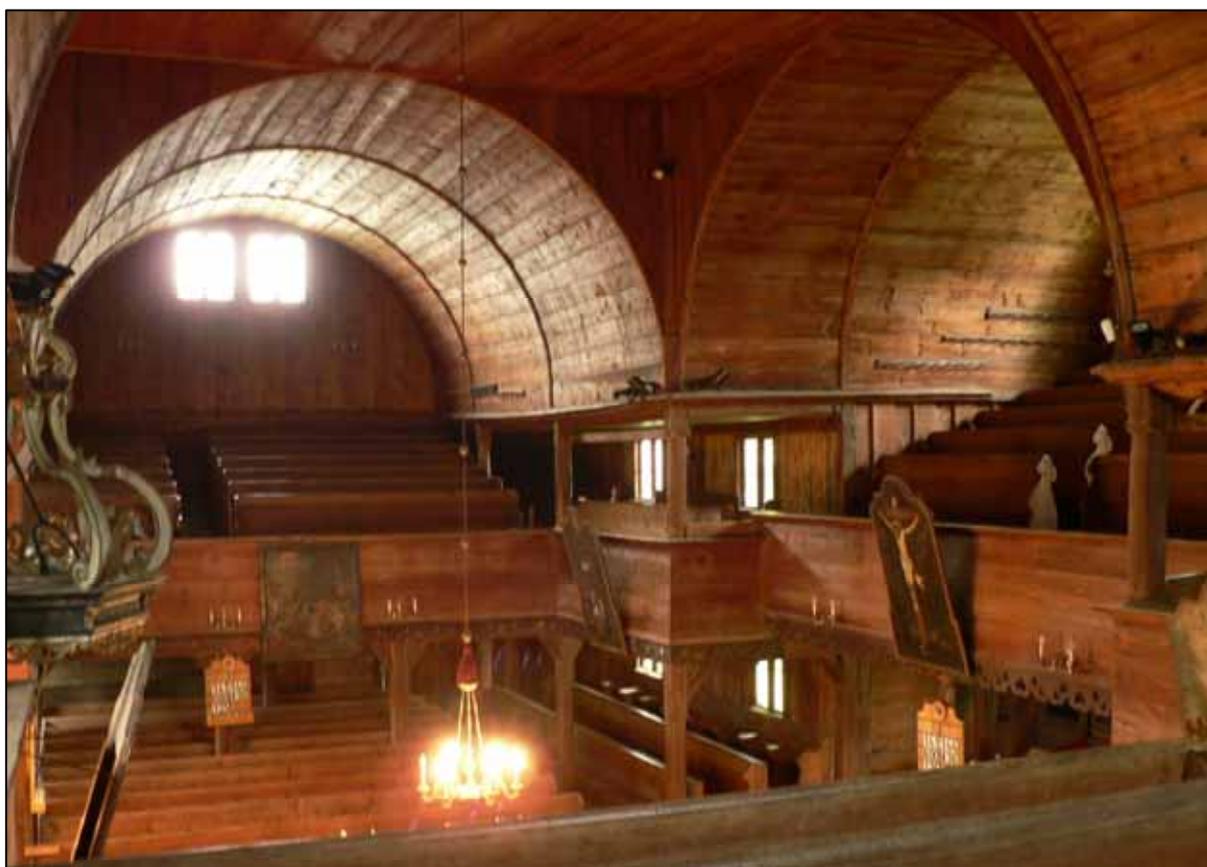
16. The wooden vaults in: (a) the Evangelical articular church in Kezmarok, (b) the late-Gothic church in Hervartov, (c) the Evangelical articular church in Hronsek

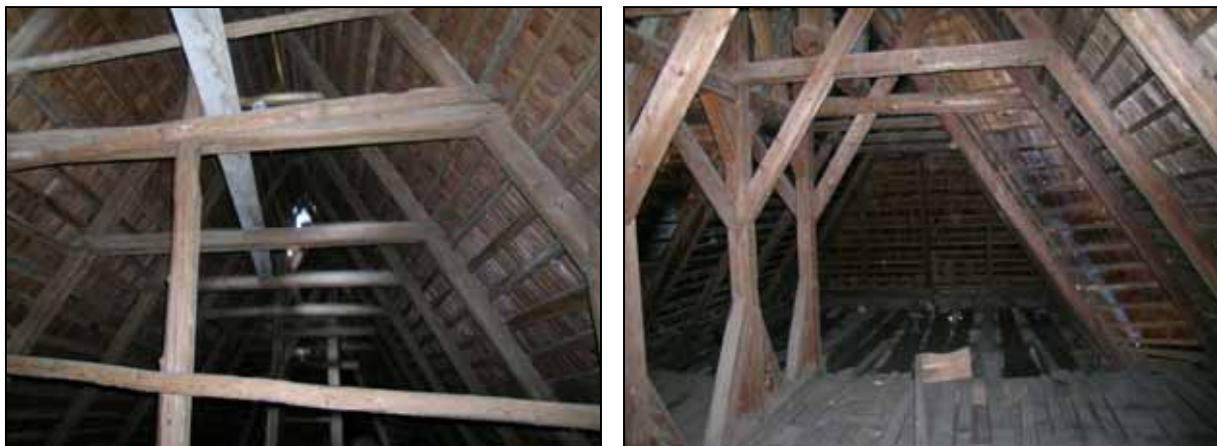
19. The roof trusses were of different constructions, which included some subtle parts (a) the post construction of the tower in Trnove, (b) Hervartov

The constructions of the roof trusses differ – collar beam structures, supporting structures, or individually developed post structures (Fig.19), and enclose the supporting structures of the vaults. Although the shapes of the rafters and other parts of the roof truss are relatively subtle – considering the outer weight of snow – there is not known a single case of the roof collapsing. It is thanks to the steep pitch of the roof.

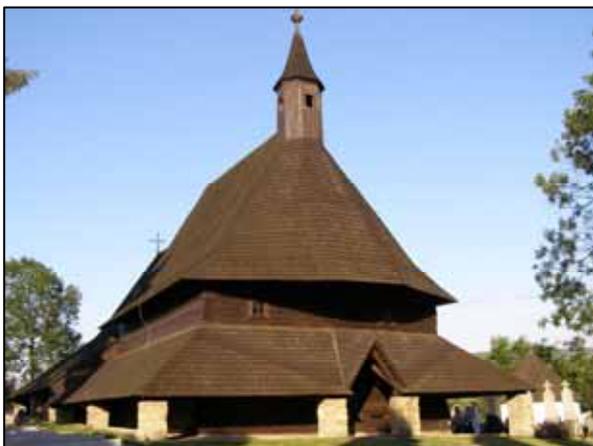
20. a The roofing material – wooden shingles – enabled a coverage of different shapes of the roofs and other constructing protrusions of the building, creating so an effective climatic protection. Tvrdosin

The covering and roofing material of the wooden churches was everywhere the same: the splinted wooden shingles (Fig.20). All the shapes and profiles of the roofs and of the projected wooden protrusions (entrances, ledges, gates, fencing) were covered with shingles. The roofs often overhung the built area of the church, the reason of which was to protect the ground parts of the wooden walls from the effects of climatic falls, and to create a shielded place for the waiting visitors. In the northern side of the Carpathian mountains (in Malopolsko – "Little Poland") the baseboard part of a church was covered with small roof to protect the bottom parts of the walls (Fig.21). In Slovakia, despite the territorial and climatic similarities, this kind of protection was not used.

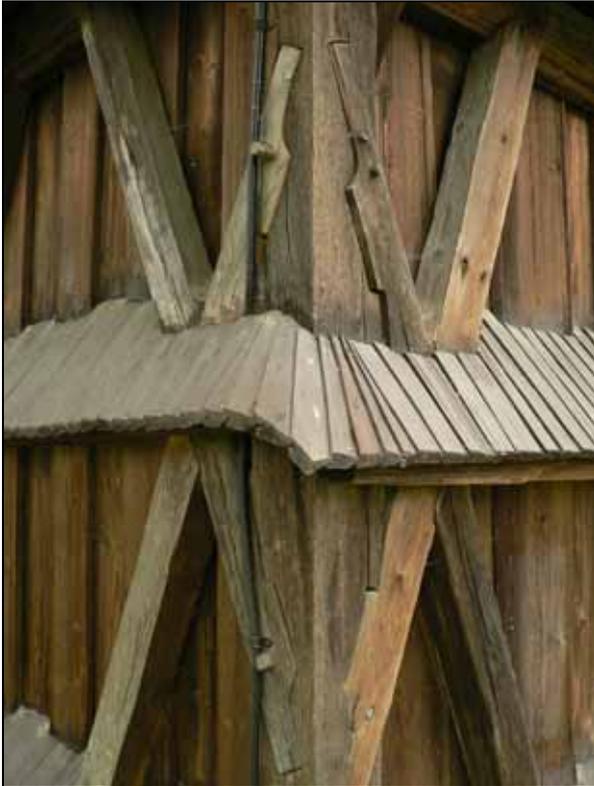
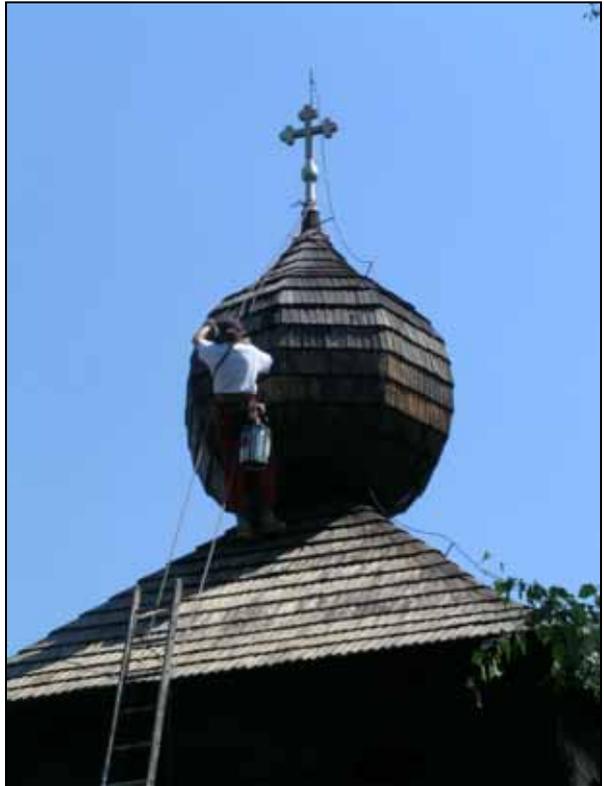
20. b,c The roofing material – wooden shingles – enabled a coverage of different shapes of the roofs and other constructing protrusions of the building, creating so an effective climatic protection. Hronsek

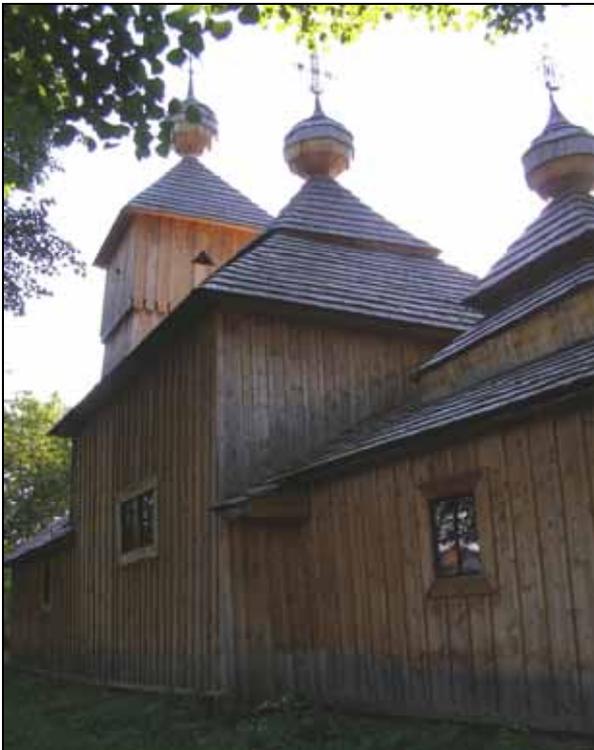
20. d,e The roofing material – wooden shingles – enabled a coverage of different shapes of the roofs and other constructing protrusions of the building, creating so an effective climatic protection. (d) Jedlinka, (e) Hervartov.

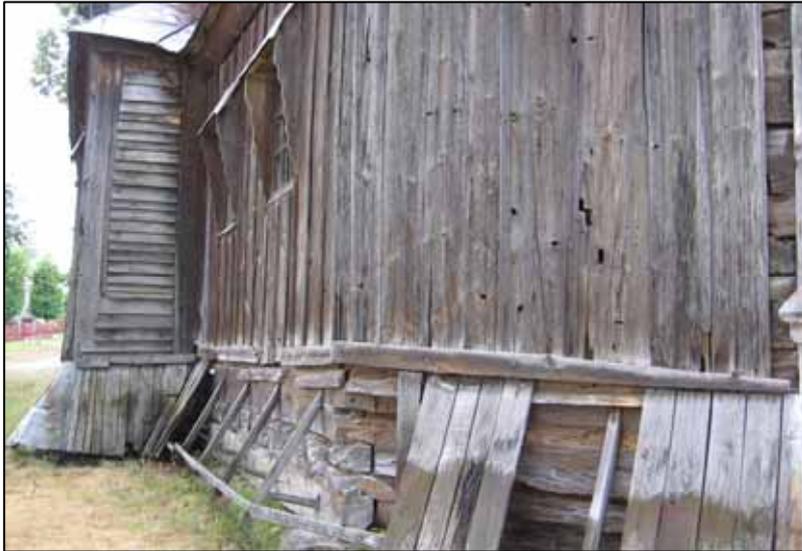
21.a Miękiż Stary, Poland: - climatic protection of the ground parts of the walls

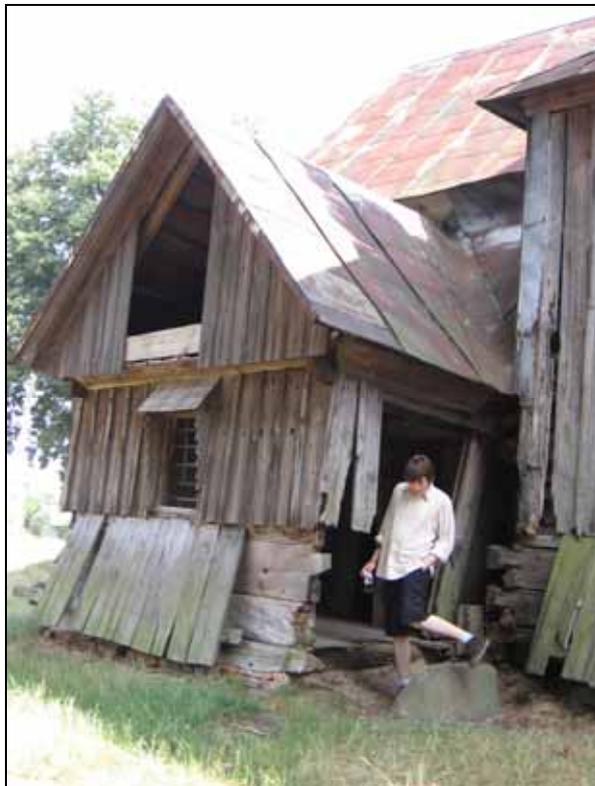
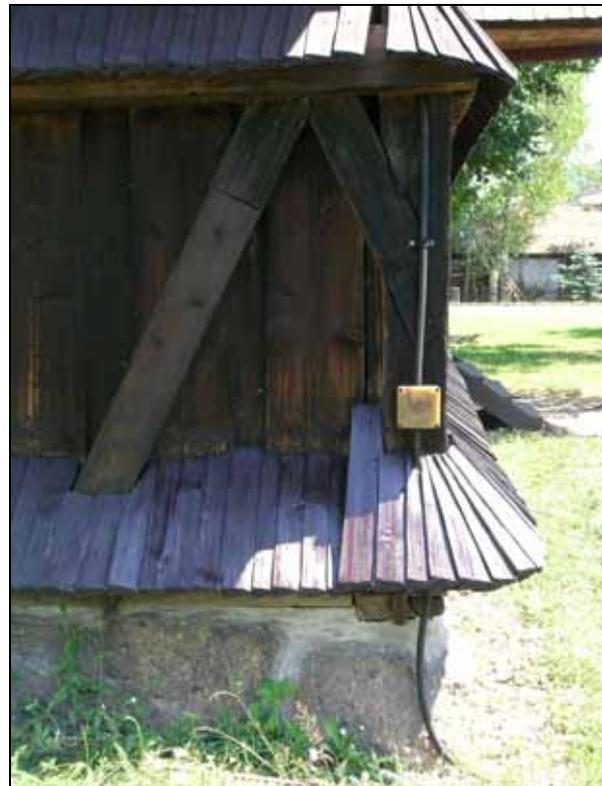
21. b,c
(b) Miękiż Stary, Poland: - climatic protection of the ground parts of the walls
(c) Protection of ground log in Hronsek.

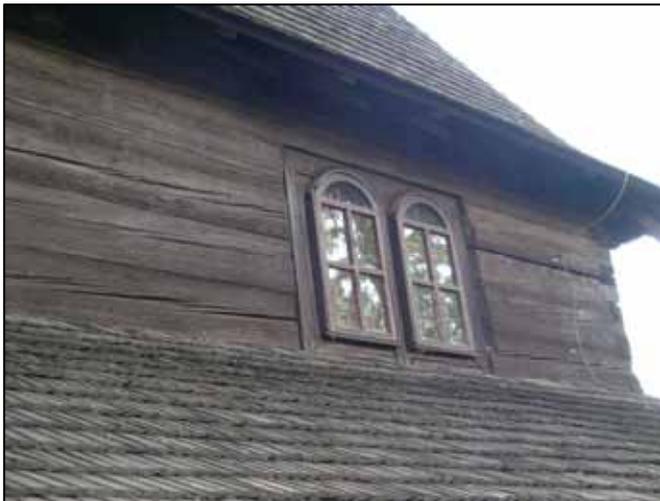
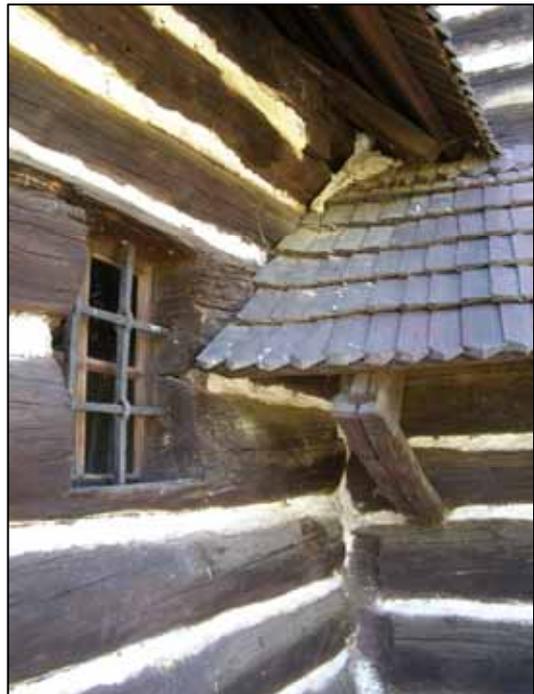
23. a,b The surface of the log-building walls:
(a) tangentially trimmed logs without any further decoration,
(b) the gaps between the logs of the circle profile, filled with dried moss, packed with clay and protected with lime coat of paint.

The surface of the log buildings was modified in different ways (Fig.23):

- a) tangentially hewed beams that created a relatively straight wall were left without any other surface decoration,
- b) the gaps between the logs of the circle profile were filled with dried moss, packed with clay and protected with lime coat of paint,
- c) the log building construction of the walls was covered by wooden planking
- d) the whole log building construction was covered with shingles.

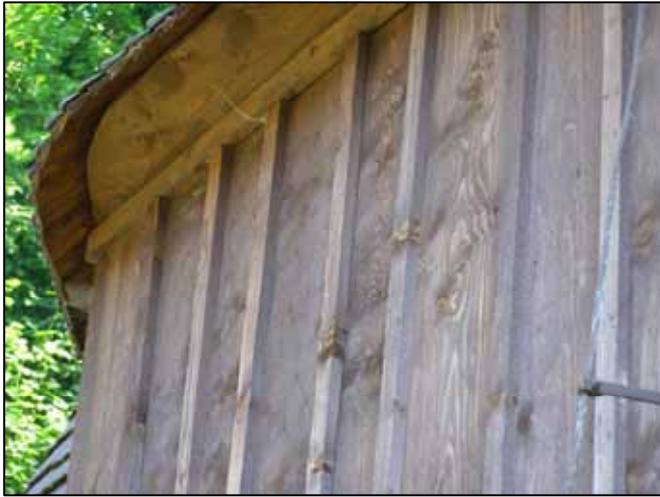
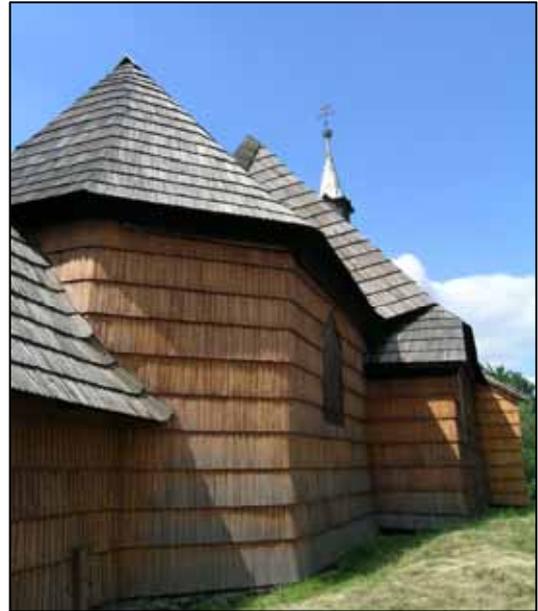
23. c,d The surface of the log-building walls:
(c) the log building construction of the walls was covered by wooden planking,
d) the shingle coverage of the log building construction.

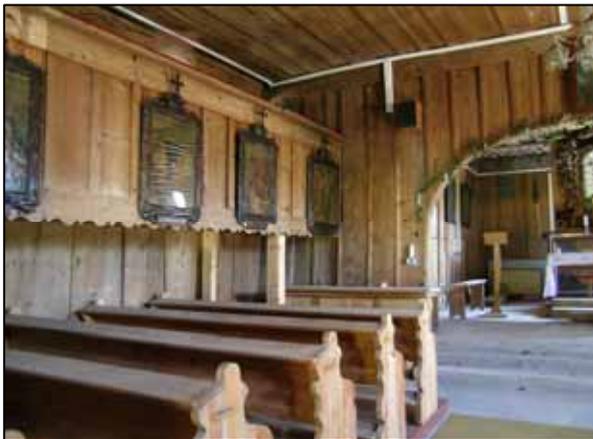
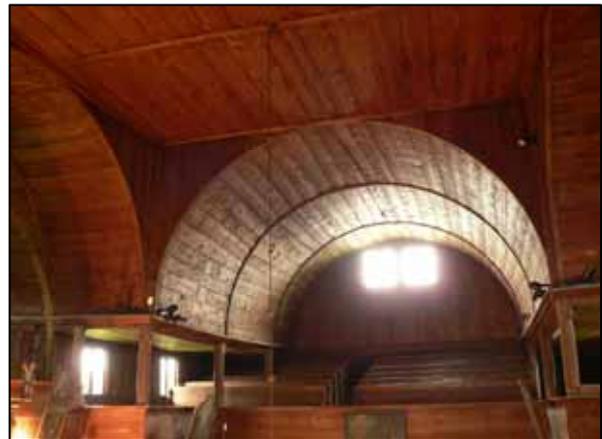
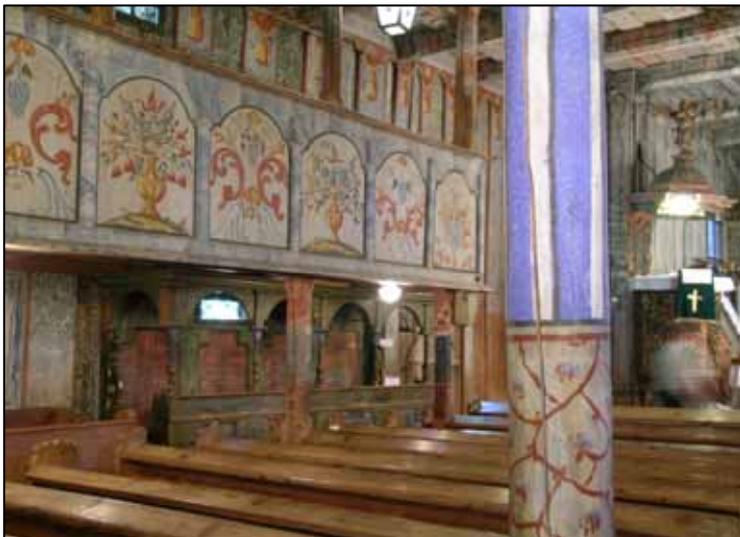
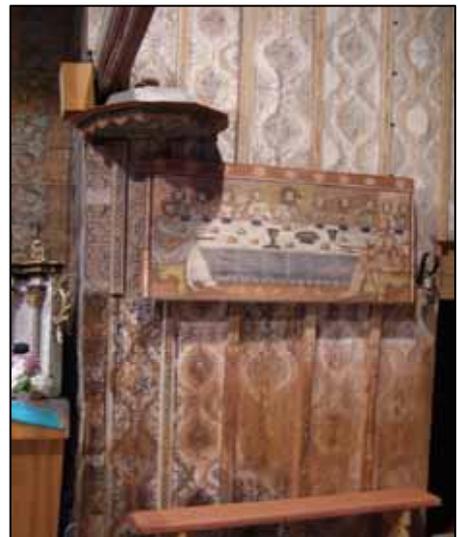
24. Surface of the walls of the interiors:
(a-b) without any further decoration (Trnove, Hronsek), (c-d) painted decoration on the wood (Lestiny, Hervartov)

The walls in the interior (Fig.24) were left bare or were covered by boarding. The walls were then left either without any other surface protection and decoration, or they were coated with paint and decorated.

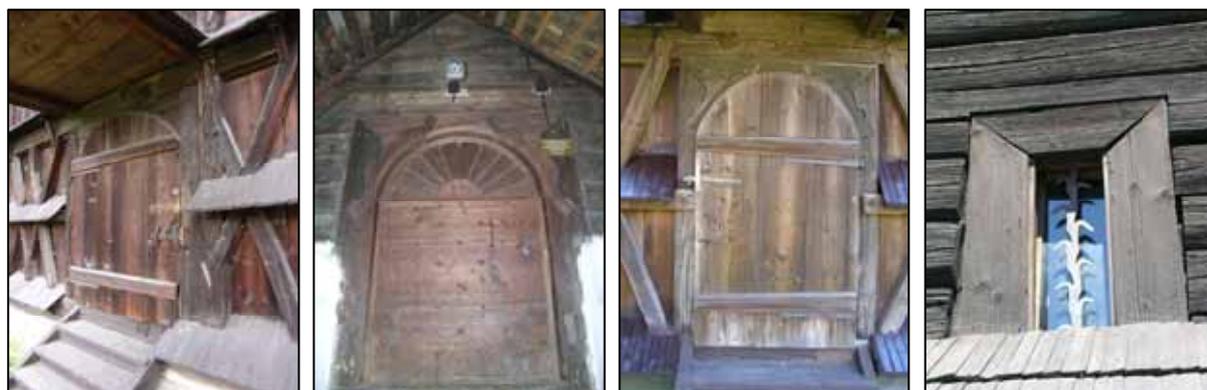
25. Constructions, framing the openings of the walls of the wooden churches, are beautiful and technically perfect.

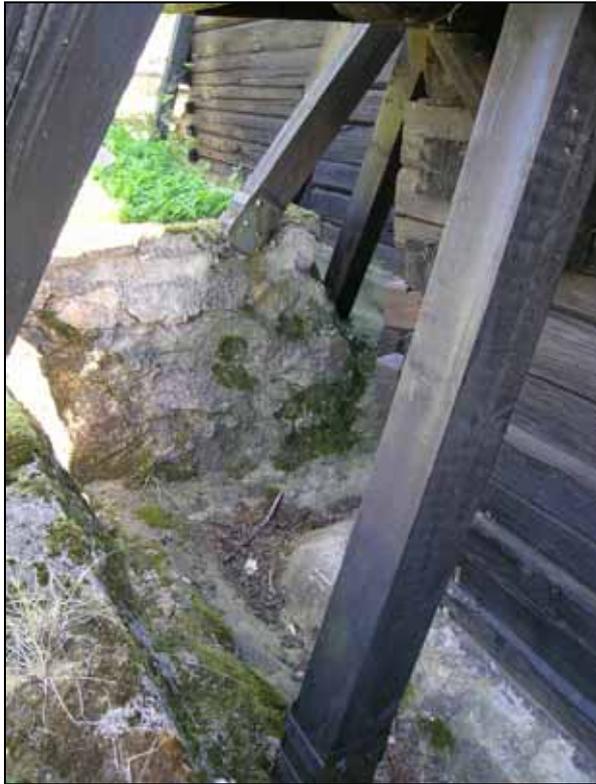
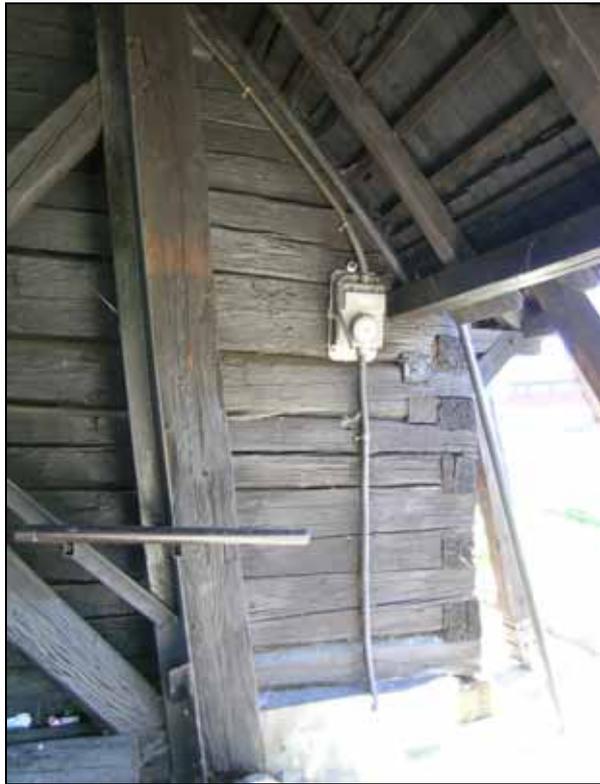
9. The conduit around the church
10. A corner deformed by the beam shift

The log building and the bell tower: The hillside, on which the church is built, declines to the southwest. The log building had previously had the shallow stone foundations, replaced in 1992-1993 with the concrete base. Concrete was used as well for the reinforcement of a conduit cut in the terrain, running around the church from the three sides. Although this intervention has stabilized the church on the hillside and enabled the better flow of the surface waters away from the building, it consequently created suitable conditions for decay and growth of the moulds in the wood of the log building. The bottom parts of the beams are strongly destroyed by dampness (caused by the layers of snow, the rising dampness from the soil, the squirting water). This problem is very distinct near the northern and eastern façade, which have only a small area exposed on the sun, that is why it is impossible to dehumidify it.

The log building of the nave and of the presbytery is connected together with a dovetail joint, which on some places is not realized properly, and so creating the deformations of the church.

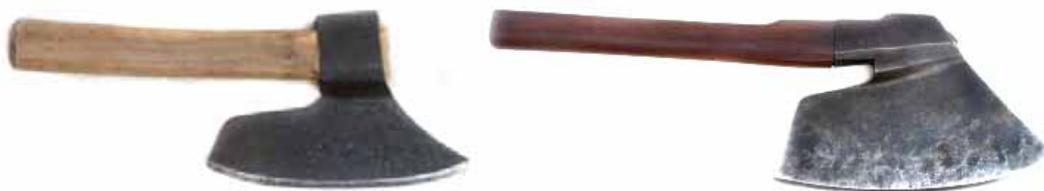
one-handed broad axe

Hlavatka ("head" axe) – is used for work with timber in the wood for cutting, carrying, and other manipulation - twisting logs, moving etc. In the past building wood was transported from northern regions of Slovakia by rivers. Wood beams were fixed together to form a raft and carried downstream to saw or market sites. Hlavatka axes were used also as a help tool of craftsmen.

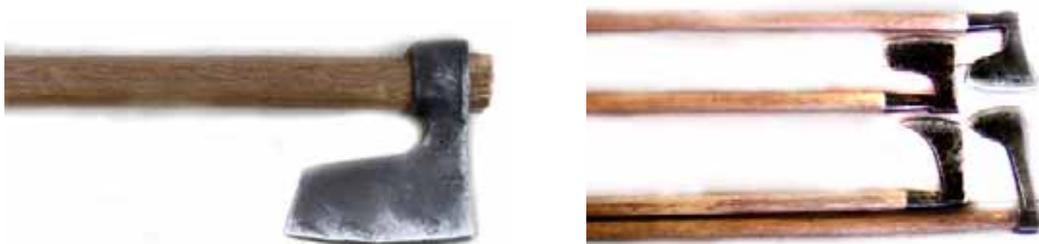
Broad axe - Širočina is another common axe type. Broad axes are used for cutting sides of a logs (circular in a section) to beams, ready for building (rectangular shaped section). Broad axes are so called right and left (curvature of cheeks), depending of which side of a log is worked on.
