RESCUING THE HIDDEN EUROPEAN WOODEN CHURCHES HERITAGE

*an International Methodology for Implementing a Database
for Restoration Projects*

Gennaro Tampone and Michela Semplici *Scientific Editors*

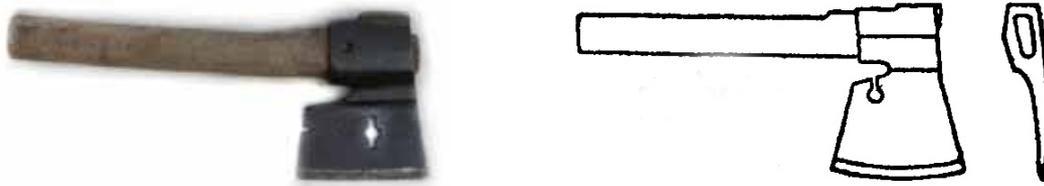
Bearded axe - Bradatica is medieval type of broad axe with long beard of an axe head and usually a much longer haft. It was used for multiple purpose, to cut wood and also to shape it.

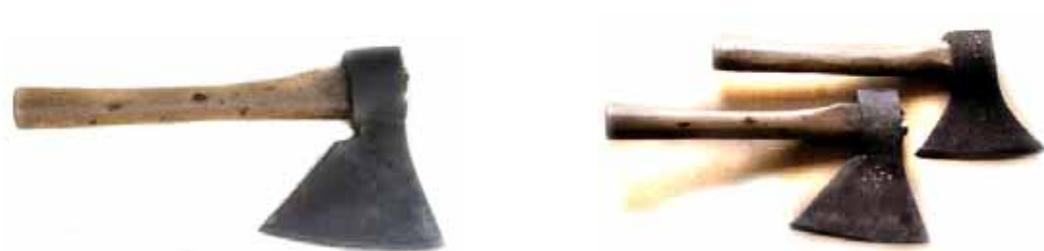
Splitting axe - Lícovka - is used for cutting edges of a beam, to create a plane on a sides of it.

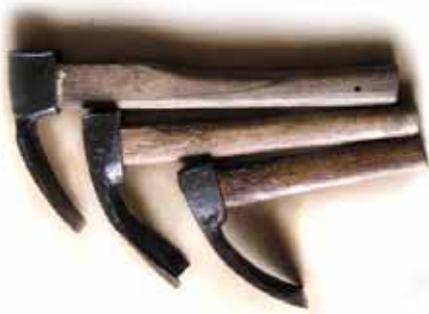
Cross axe – Krížovka - is also used for cutting holes or shaping edges, carving etc. Some examples of work with cross axe.

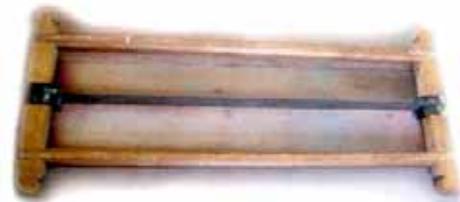
Two-man frame saw, Roman Empire

Two-man frame saw – *Dvojmužná rámová pila* – was used a centuries ago as proofs stone relief from time of Roman Empire. This saw was used to divide beams or shorten them.

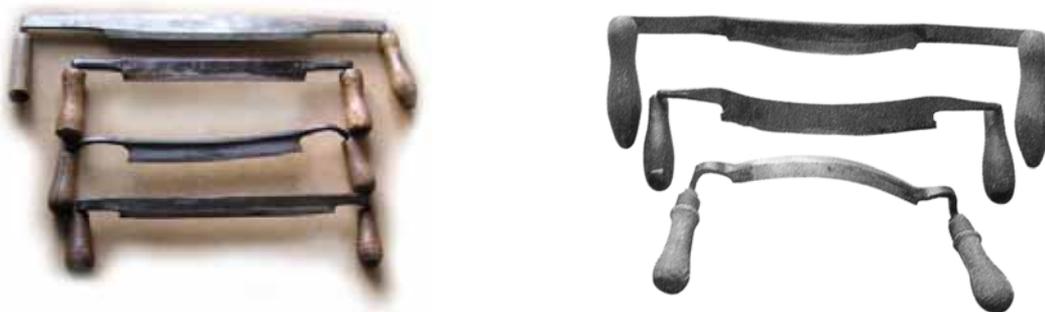
Two-handed knives – obojručný nôž – is used for primary work on a wooden log, removing bark and shaping prepared beams.

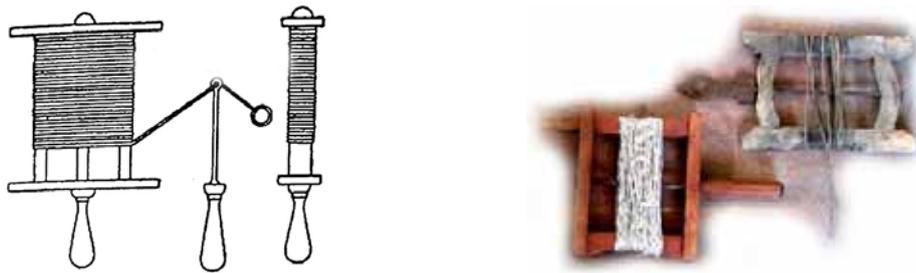
Measurement tools

Kolovrátok – was used for measuring distances, helping drawing lines.

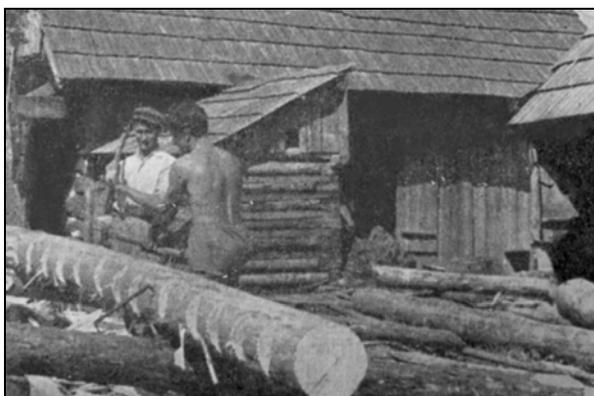
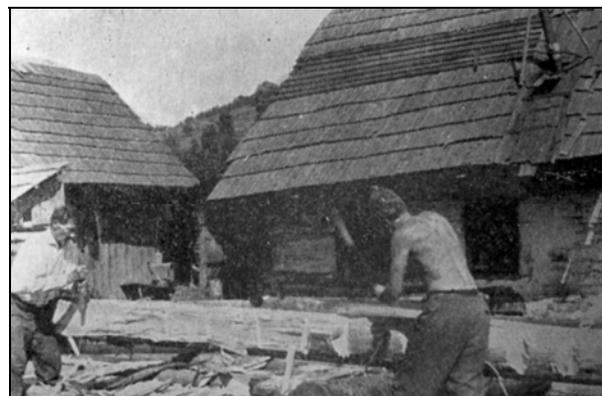
Cutting edges by means of V shaped regularly made cuts is the only one possibility of cut away unnecessary material. Is cutt-away parts would be too long, axe would be after some distance squeezed between wood mass.

Cutting beams for building, Kysuce region, around 1950.

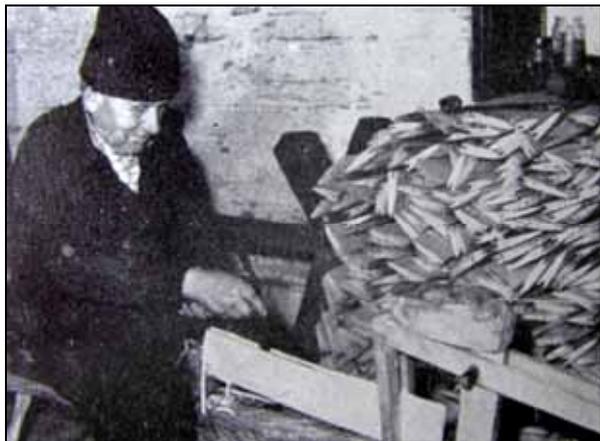
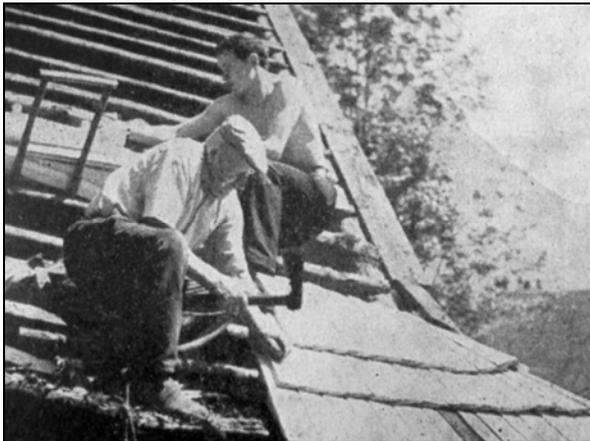
Shingles are wooden boards 50-60 cm long, 7-15 cm wide and 1,5 thick. They have a blade on one side and side along cut on the other side, to be easily connected side by side to one another. Shingles could be laid down in one or two layers. Blade side is oriented to a prevailing winds side, also the first row at top of the roof is put that way that groin end of shingles is positioned to south and plane of shingles to the north.

Older way of making much more durable shingles is to cut them from a log in a groin direction. Cutted shingles can be safe roof cover for a 30 or 40 years. New way is to saw them, this is cheaper, but shingles are less durable to weather conditions.

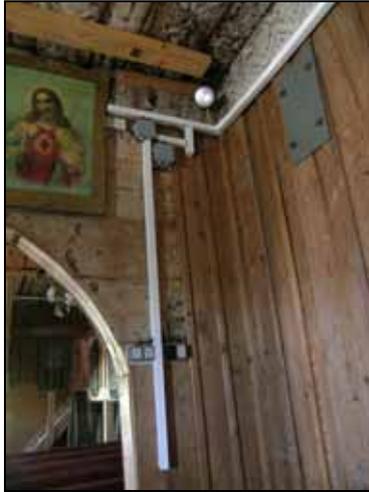
1. Improper tracing.
2. Emergency use of indoor and industrial lightings.
3. Improper chandelier arrangement.

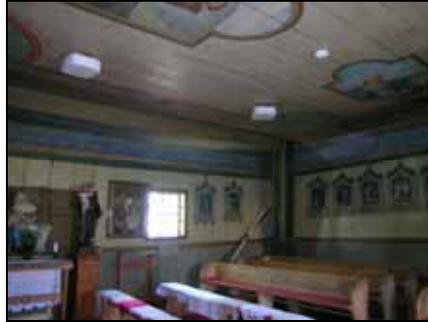
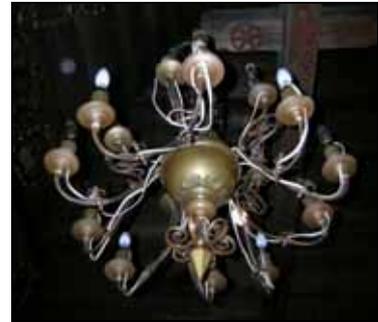
4. Improper lighting decoration – dazzling may occur.
5. Chandelier appeals to be strange in wooden church.
6. Proper covering of electrical equipment.

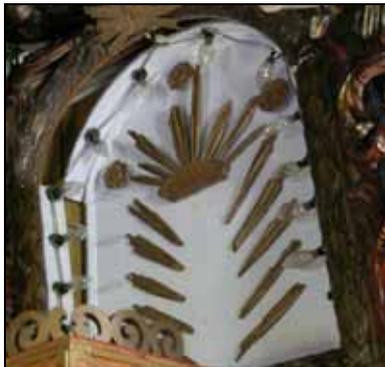
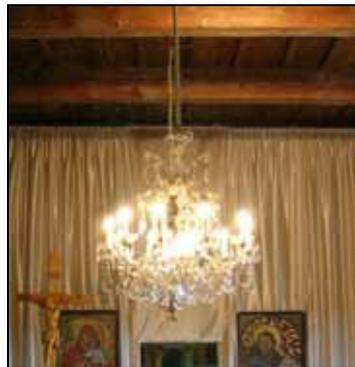
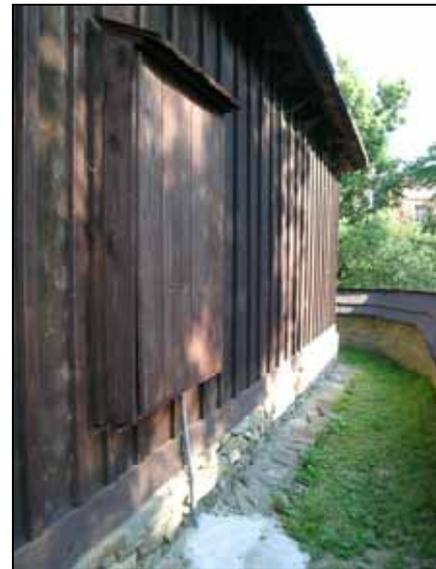
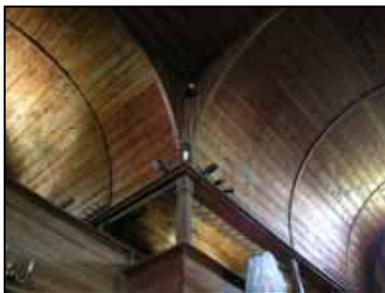
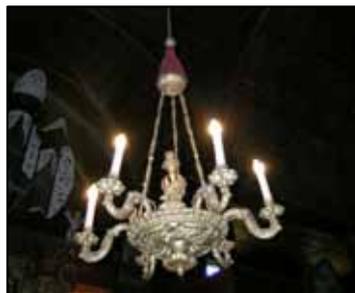
7. Proper lighting adjustment.

8. The detail of chandelier with coloured adjustment processed earlier.

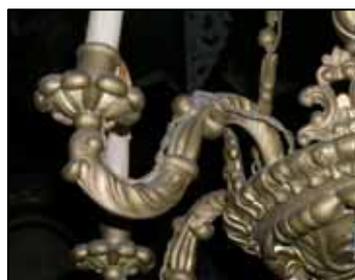
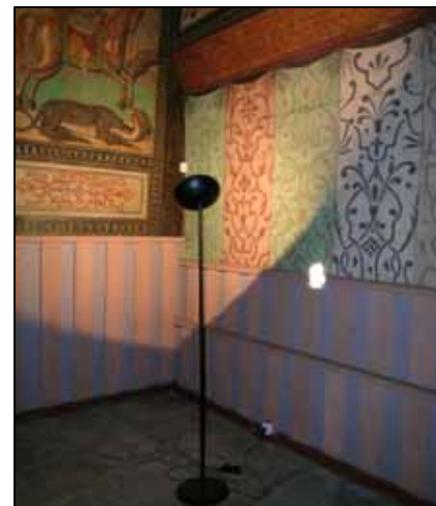
9. Proper wall illumination, with the help of separate lighting or lanterns.

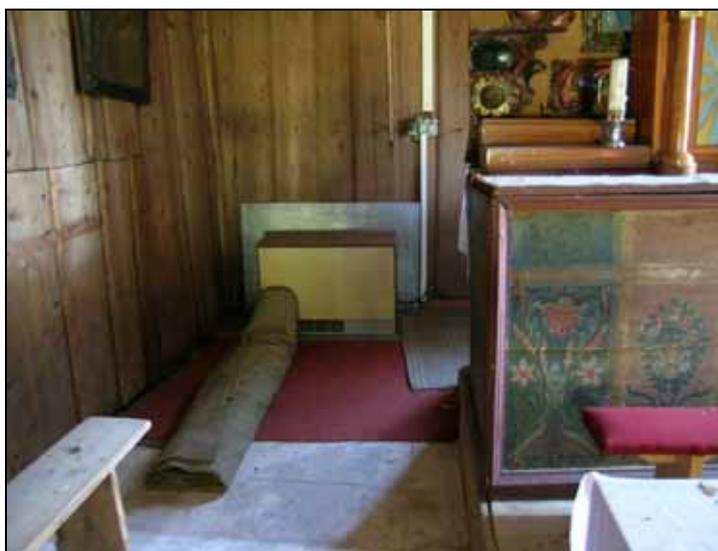
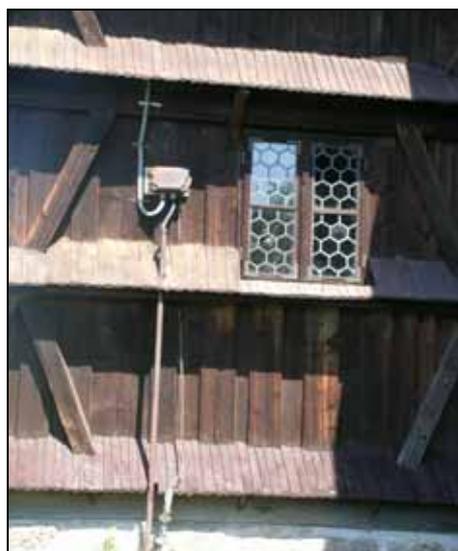
7. 8.

Fire protection precautions exclude shouldering of distribution boards into wooden wardrobes, or its garnishing by flammable material. Moreover, distribution boards must be distinctively marked, easily identifiable, with the notice, if the main power cut-off is placed. Documentation about current condition of installation should be placed in the inner part of the door.

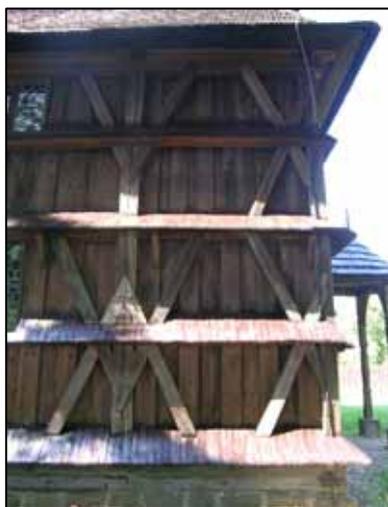
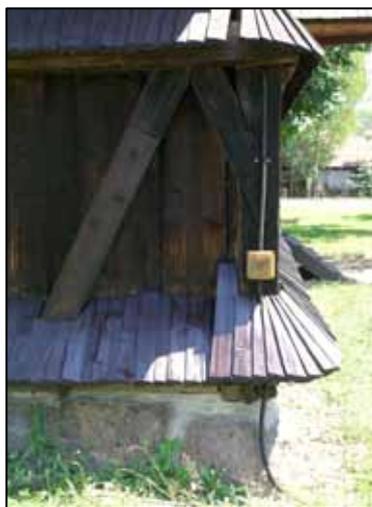
9. 10.

finger joint with accumulating rods. Attachment of metal structure of bells is important. More bells have usually separate grounding. To prolong the lifetime of arrester, a copper material is used, however, this can also be of a worse impact – in cases where the attachment is made with steel (zinc-coated) plumbing products, the use of bimetallic switch-over is necessary.

This switchover, however, is destroyed after lightning stroke. Apparently, copper-conducting material is reasonable, if plumbing products are made of copper as well. The propriety of aluminium high-conductivity cables is arguable due to lower temperature of aluminium melting and also due to destructive chemical reaction with calciferous building materials. The distance between collecting and conducting conduits from flammable material is important. Example of dangerous installation is in the Fig. 04, Fig 09, Fig 10.

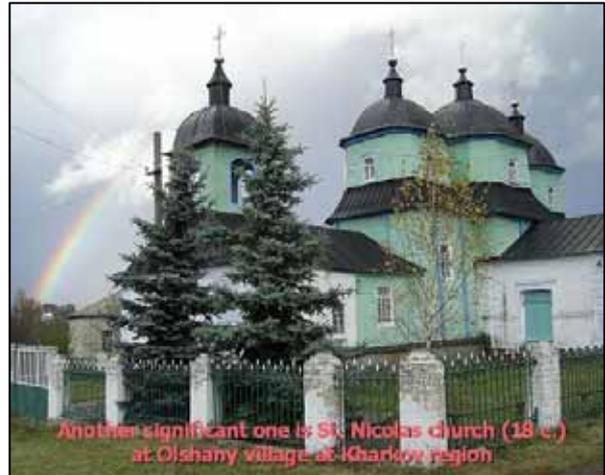
Vvedenskaya church belongs to the archaic wooden triple-shear (log-house) type of buildings with central two-high volume. The building is oriented west-east, it is cross-shaped and consists of two hem octagon (altar and outhouse) and octagonal central part and has a pyramidal composition. Triple-shear structure of volume-dimension composition that was created under the influence of baroque, form of plan, sloping walls, original absence of paintings in the interior. allow to ascribe this architectural monument to the ancient buildings that preceded Limanskaya school of wooden architecture of Livoberezhnaya Ukraine.

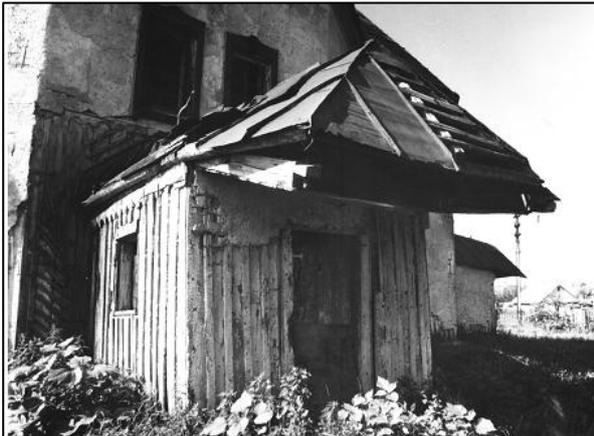
For the purpose of social property fire protection in the 60-ties of 20-th century the building was coated with clay and whitewashed on the outside. From time to time the roof was repaired. But the technical state of the temple was decreasing. The permanent dampening of the walls brought to the intensive destruction of the log-house. Especially it occurred in the places of parts connections. Under the layer of clay whitewash the ancient wooden boarding was quickly destroyed.

The exploitation of church as a storehouse leads to the destruction of the lower beam level. The lack of ventilation and premises' aeration lead to the appearance of mould. Later on the fungus spreaded over the entire surface of the walls and the wooden floor.

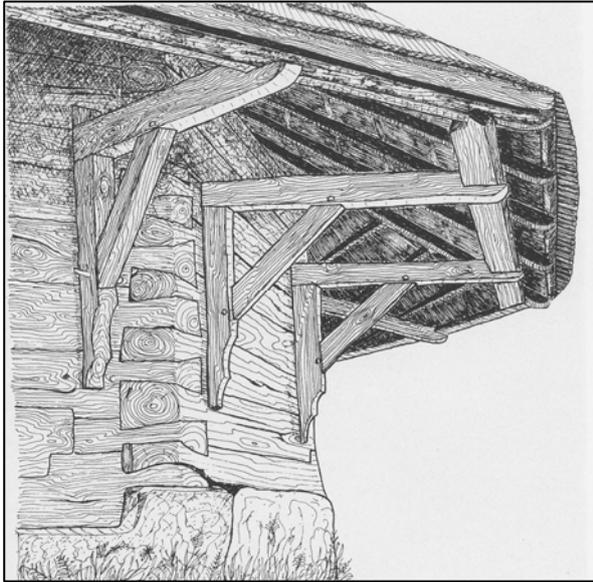
4. Attached brackets for the support of the eave, connection of the logs at an angle for the apse of the Catholic Church at Poniszowice, Silesia (from Buxton, cit.)

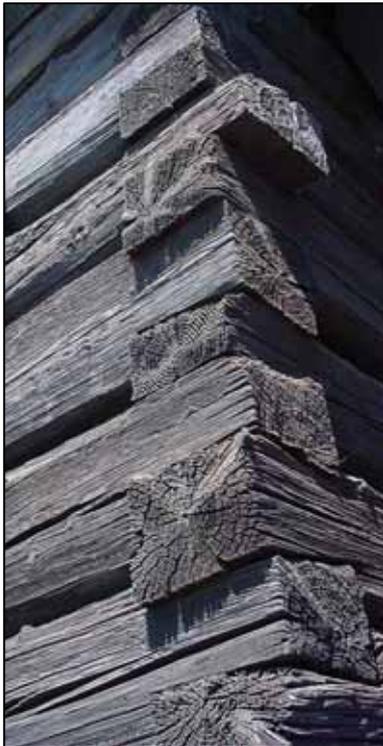
37. The materials are of good quality and well dressed, the building technique is suitable except for the absence of clogging in the Church of Trnové (Slovak Republic)

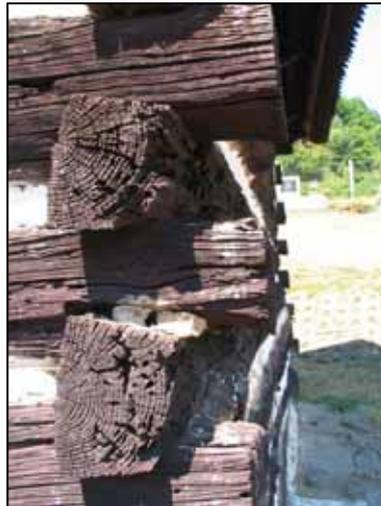
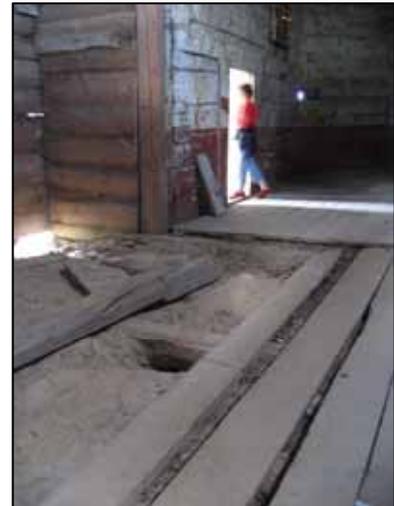
38. The exterior walls of the Church of Brezany are made, typically for Slovak, with logs put at a distance, the gap being in-filled with mortar. The logs are of mediocre quality and twisted, the connections not made in a suitable way

A few typologies of the building technique have been detected, amongst these the constructions with entire or half (mainly Slovakia) logs, with the round or squared logs; in Slovakia another type has been observed (Brezany) that has logs put at a distance in vertical, the room in-between filled with poor mortar or earth, the whole frame being sometimes covered with plaster; in the same church the base of the log construction is larger than the medium level, i.e. the first part of the walls is not vertical but inclined inwards, to be considered an efficient device to contribute to stability.

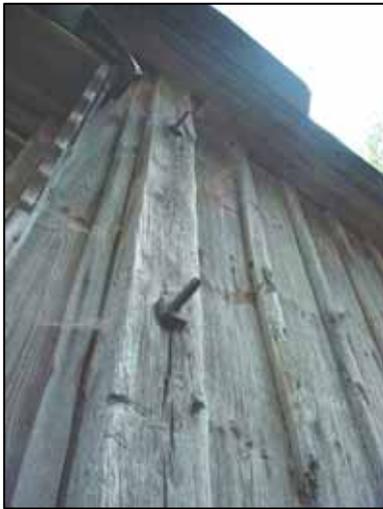
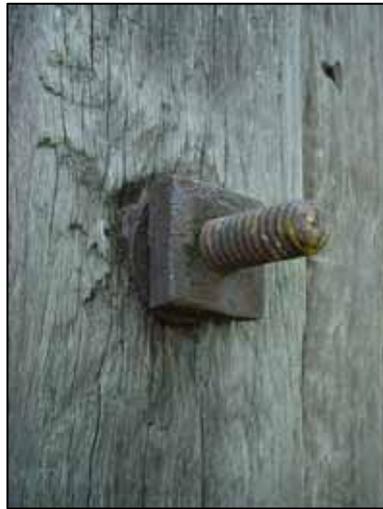
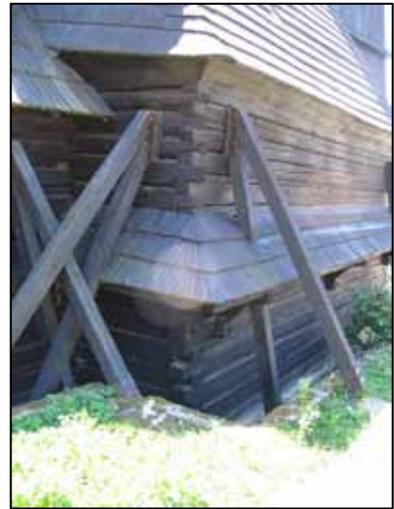
40. Strengthening devices (plank and bolts) at Mięksisz Stary (Poland)

41. Mięksisz Stary (Poland) detail of the pre-industrial bolt

42. Huge shoring work for the church of Trnové (Slovak Republic), affected with rigid rotation caused by soil settlement

But in Trnové large strengthening works are to be found, not only the shoring with the wooden props already quoted, but the three dimensional steel frames at the base of the belfry, which is still affected with inclined translation proving that the failure is still active.

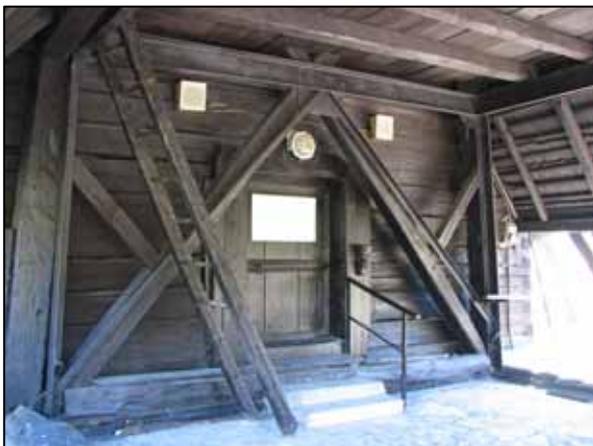
44. Long and bent (own weight, point loading) props for the unsteady church of Boguszyce (Poland)

Very recent are a few propping works but made without a concern for the slenderness of the poles, really too thin in comparison with the loads and the length: the repair was not efficient at least in two or three cases, by instance Brwilno and Boguszyce, Trnové (Slovakia). The props are too long, besides they were left in the rain without protection: now they are bent by point loading, one is twisted, several of them are rotted by fungi and eaten by beetles.

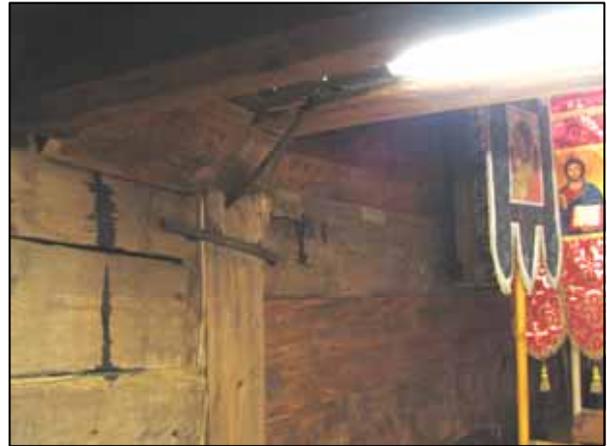
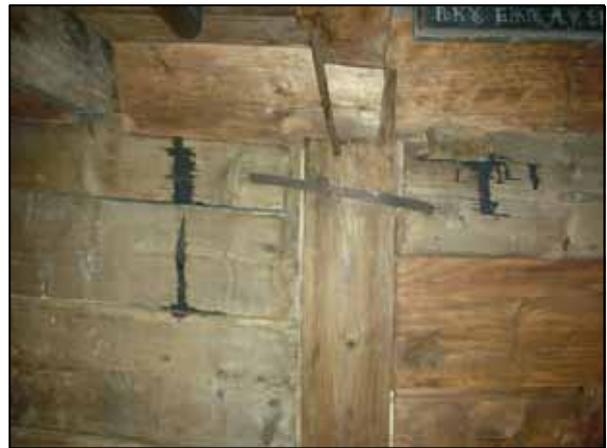
46, 47. Iron cramps at the Jedlinka's structure (Slovak Republic)

A complicate strengthening system of a floor, made with nicely shaped wrought iron, was observed in Jedlinka.

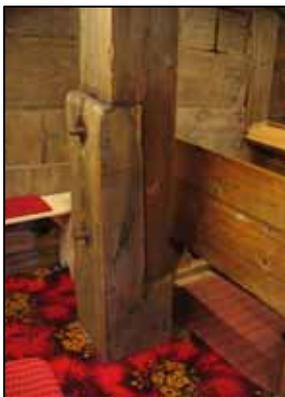
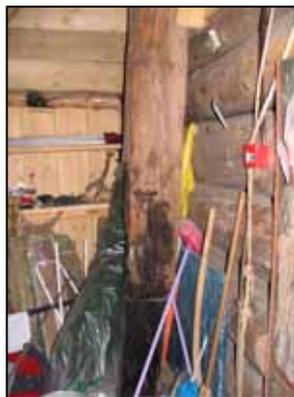
48, 49. Old repair work of the base of the bent pillars of the Church of Jedlinka (Slovak Republic)

Some partial replacements of bent uprights have been seen in Jedlinka, a measure to be connected with the rottenness of the pillars and the inclination of the belfry.

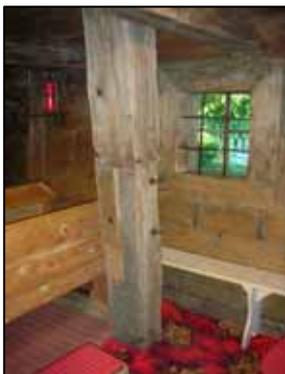
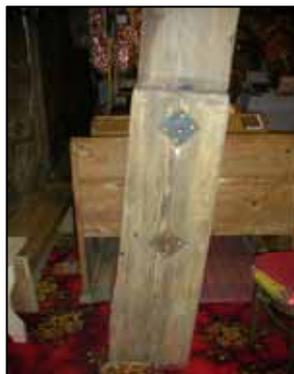
50, 51. Old and new repair work of the base of the bent pillars of the Church of Jedlinka (Slovak Republic)

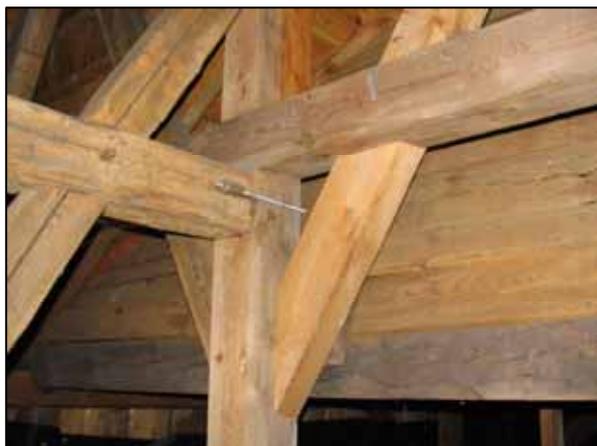
52. Insertion of new elements in the structure of the roof of the church of Letowo (Poland)

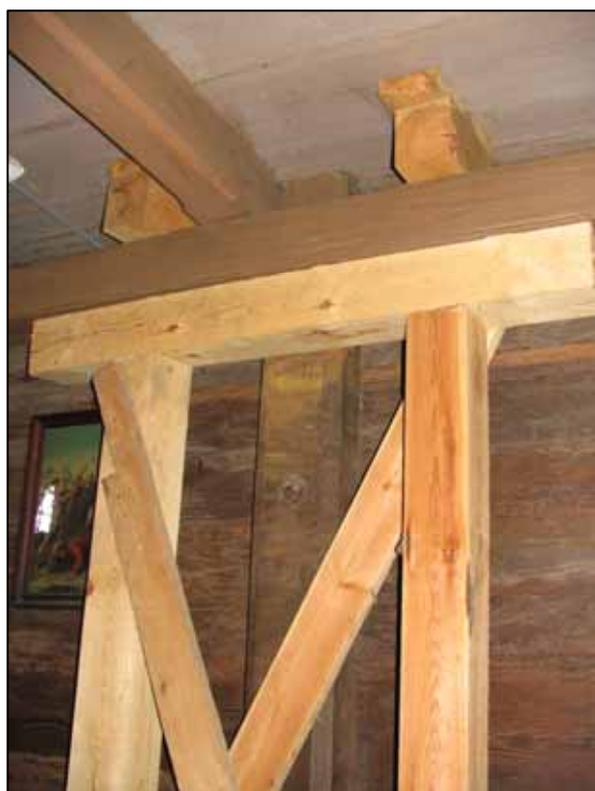
54, 55. Biotic attacks at the wooden shoring system of Trnové (Slovak Republic), maximum at the sections close to the steel boxes; the inside prop is bent and twisted

They are also evident, by similar cracks and huge timber shoring paralleled by steel ties, on the church of Trnové, Slovakia, where the building is resting on an inclined soil. The wooden props, already bent (as effect of point loading; the failure of the building was still active when they were put in place) and rotted by fungi, are too long, inefficient and dangerous for people walking around, and they cause more weight on the broken structure.

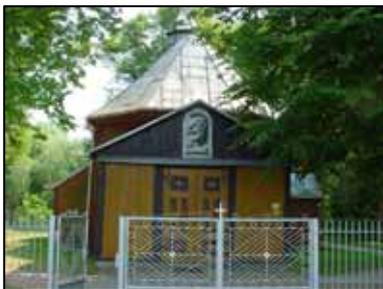
57. Church of Brwilno, Poland. General rotation of the building caused by soil settlement, erosion of the banking, wrong inclination of the placement soil etc.

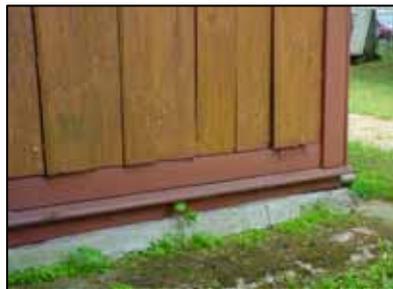
58. Brwilno. The main horizontal components (tension) of the soil settlement are made evident by the vertical crack of recent concrete tie at the foundation level

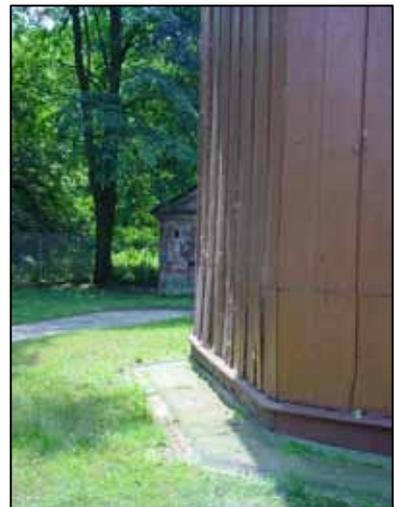
59. Brwilno. The main horizontal components (tension) of the soil settlement are also evident by the widening of the base of the building

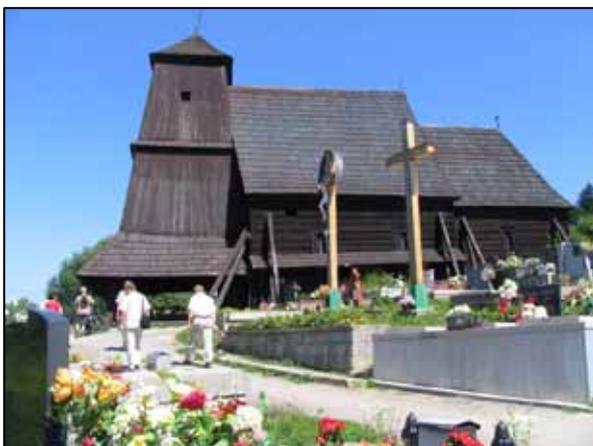
60. The imposing church of Trnové (Slovak Republic) was hit by a large uniform soil settlement with rotation of the entire building to the left and relative rotation of the belfry towards the hall.

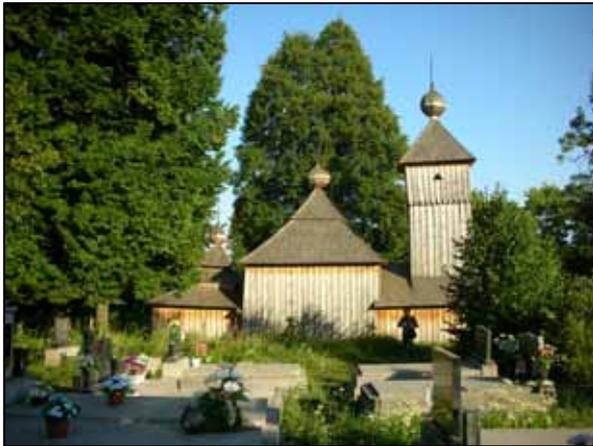
62. Wide intermediate soil settlement of the wooden church of Jedlinka, evidenced by the inward rotation of the belfry and the extreme body on the left. The settlement was started by the vertical translation of the central body

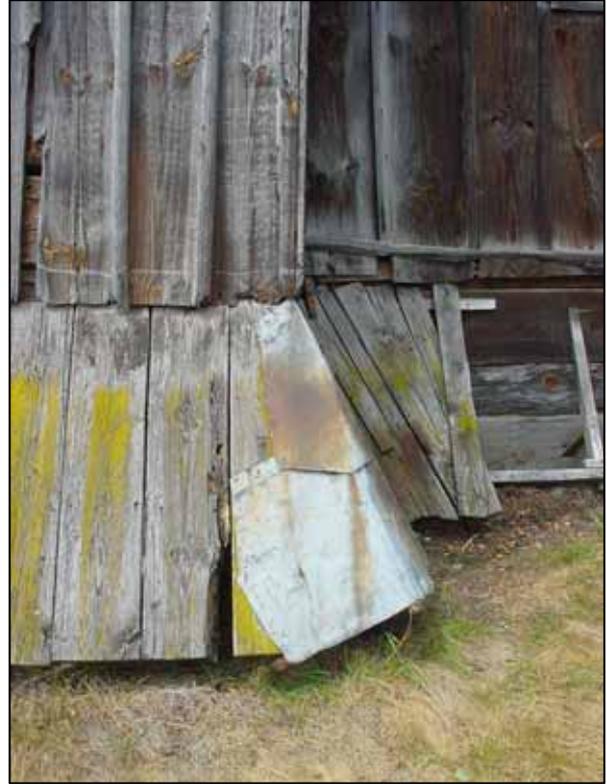
65, 66. The Church of Mięksiz Stary, Cracow circle, shows also algal settlements

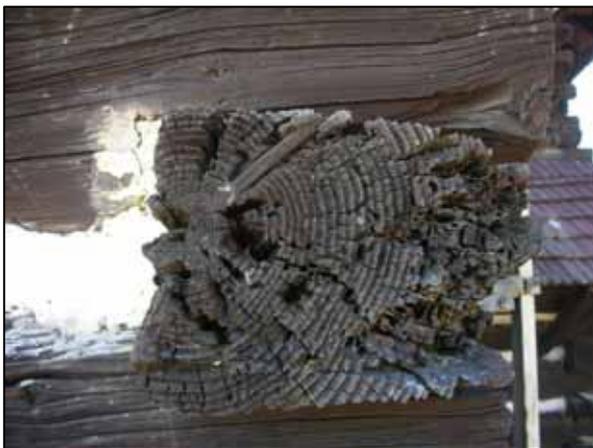
67. The log construction of the Church of Brezany (Slovak Republic) is extensively attacked by beetles

68. Mięksiz Stary (Poland).
Beetles making themselves busy on the walls of the church

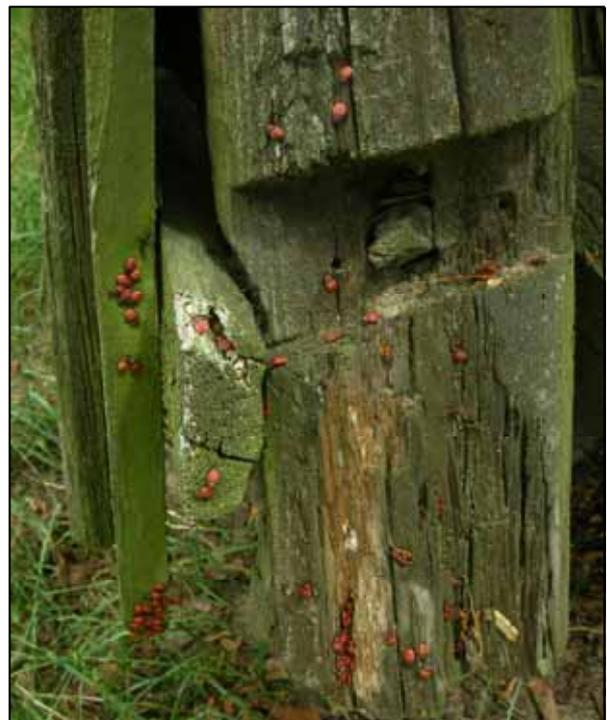
69, 70. An interacting combination of algal, entomatic, micotic attack to the basement of the Church of Mięksiz Stary is also responsible of a structural failure

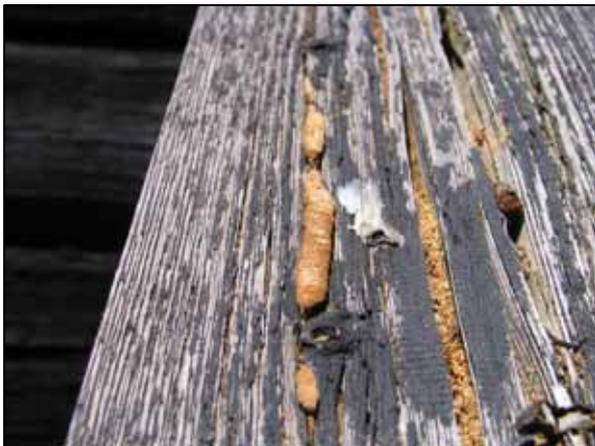
71. Biotic attacks to the "new" props of the shoring put in place at the church of Trnové

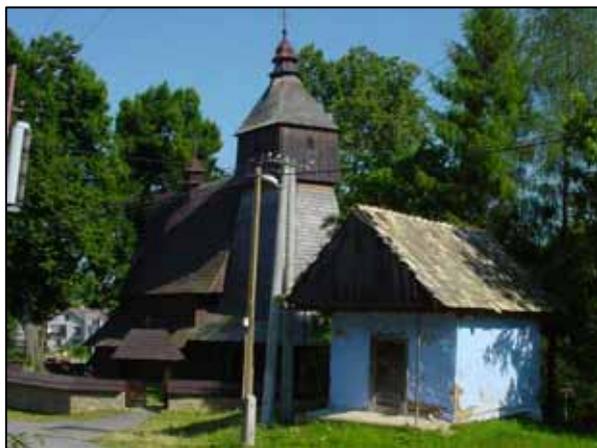
72. Site of the Church of Hervartov (Slovak Republic), spoilt by electricity and telephone poles and cables, concrete posts etc.

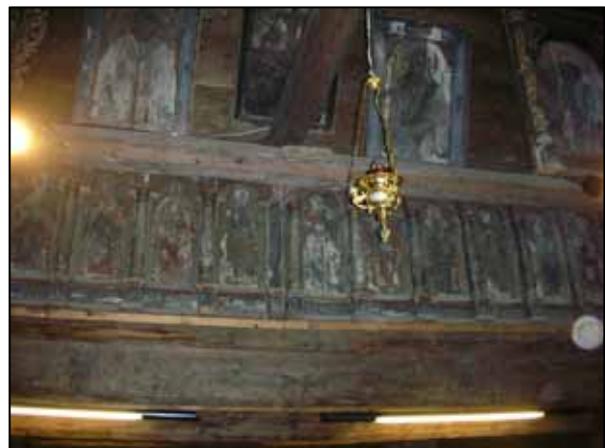
73. Old and valuable architectural wooden casing for a series of paintings, with *lacunae*, of Characters. Church of Jedlinka.

Most of the paintings present in the churches visited are in a poor condition. They must be restored; but it is personal opinion of the author that restoration in this case should not mean the repainting of the *lacunae*, the contents of which are a loss for ever, but cleaning, fixing the colours etc. It is the case of Jedlinka where a valuable painting in an architectural frame is strongly decayed and many parts of the human figures are missing: the lasting authentic parts are not to be spoilt by new, subjective parts.

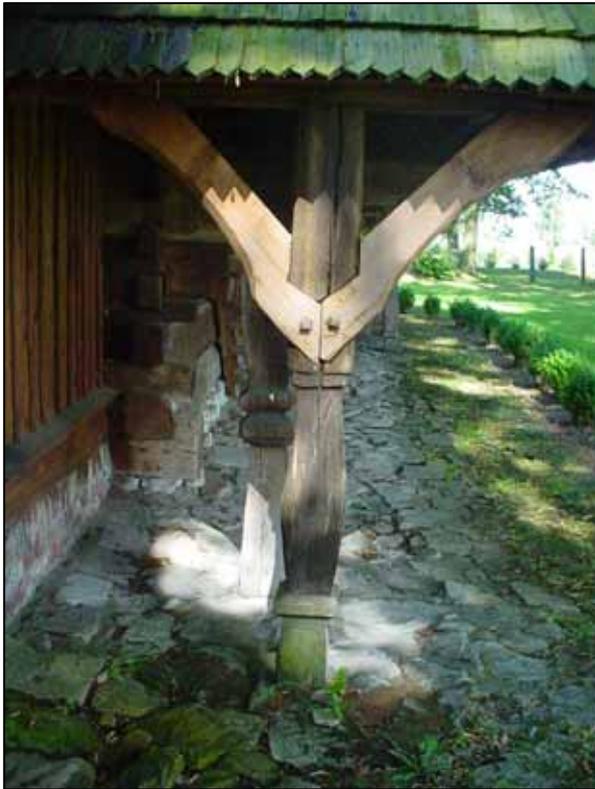
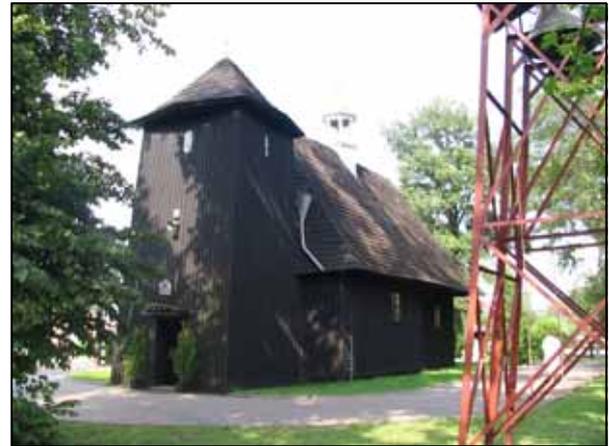
74. Wrong design of the copy of braces, responsible for the crack of the woden elements at the connection sections

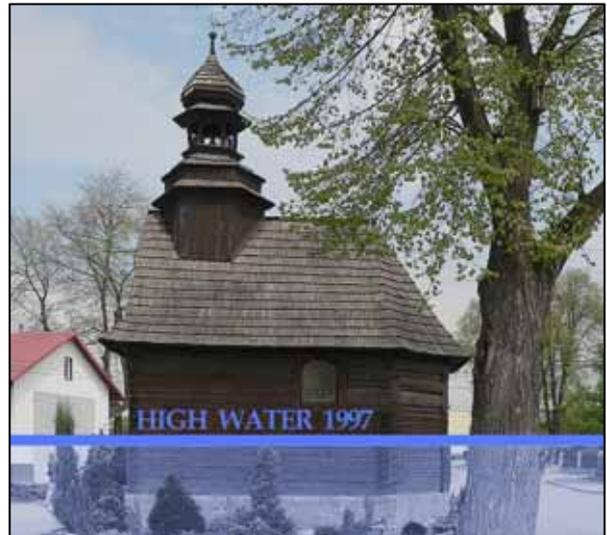
2a. BUKÓW - Rosary Chapel - the water level during the great flood in 1997.

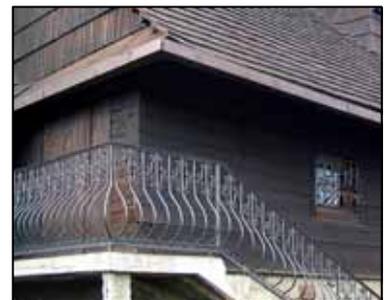
8c. RYBNIK-WIELOPOLE (originally GIERAŁTOWICE) - church of St. Catherine - reinforced concrete stair with bent iron balustrade.
